**WEBINAR MARCH 16<sup>TH</sup> 2023**

**EMERGENCY WORKS  
ON THE RHÔNE DELTA LEVEES  
INTERVENTIONS PRINCIPLES  
&  
FEEDBACK ON RECENT FLOOD  
EVENTS FROM 1993 TO 2016**

**THIBAUT MALLET  
SYMADREM, FR**

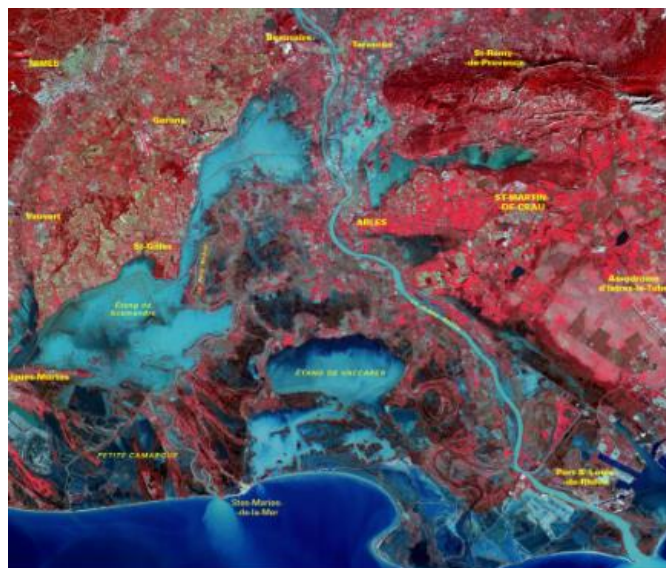
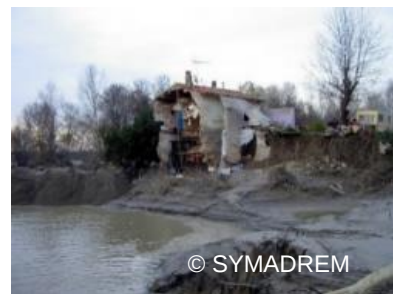
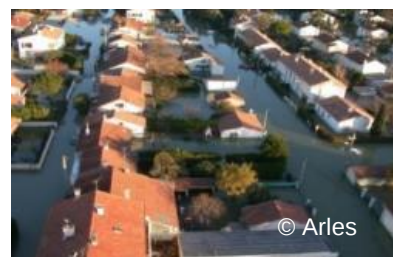
December 2003

4 breaches and spilled volume  $\cong 230 \text{ million m}^3$   
People flooded : 12 000 à 14 400 (no dead)  
Cost of damages  $\cong 365 \text{ à } 700 \text{ million } \text{€}$

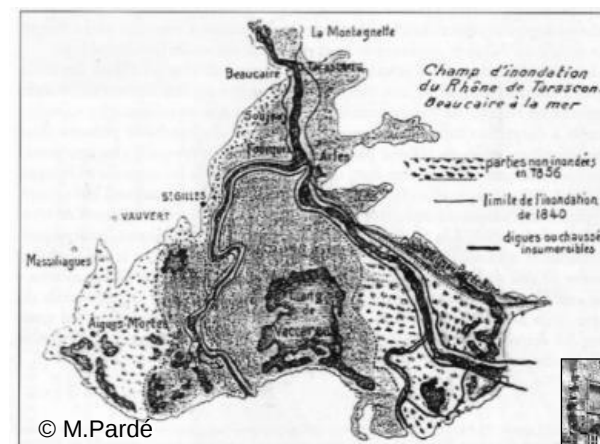
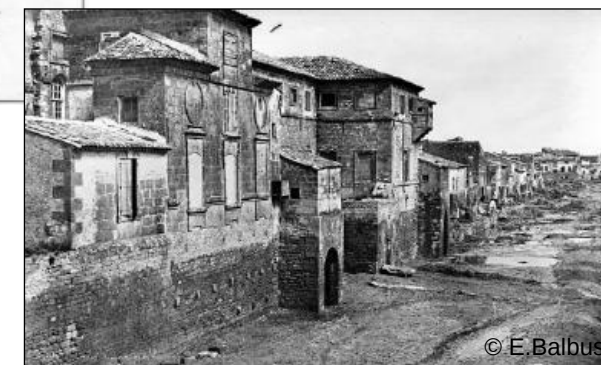
November 1840 & May 1856

Spilled volume in 1840 and 1856  $\cong 2,8 \text{ \& } 1,8 \text{ billion m}^3$   
Estimated cost of damages today  $> 2 \text{ billion } \text{€}$

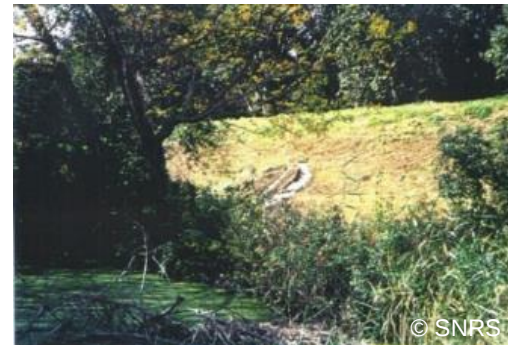
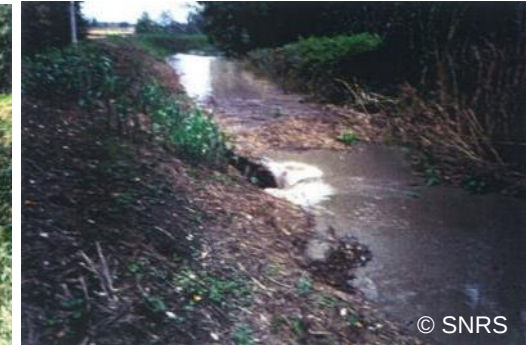
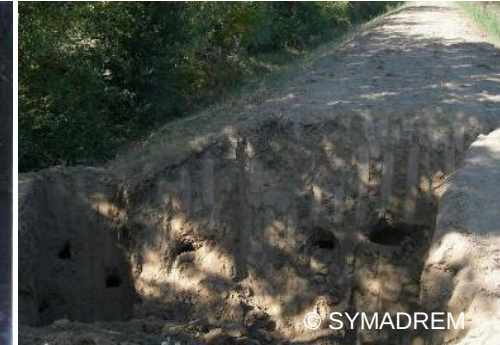
80 % in badger burrows

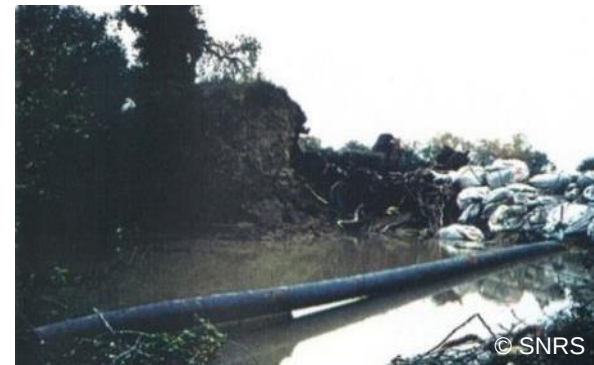
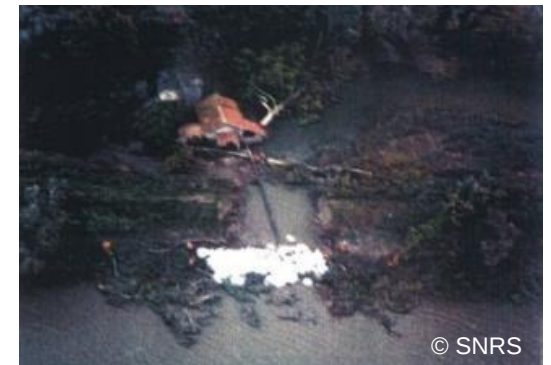
20 % along crossing pipes

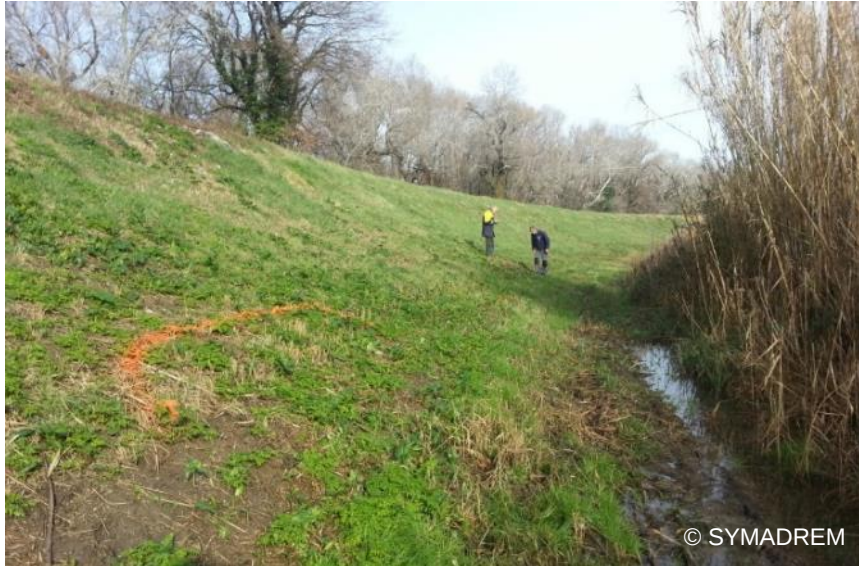
Clear water seepage is fairly common during floods...

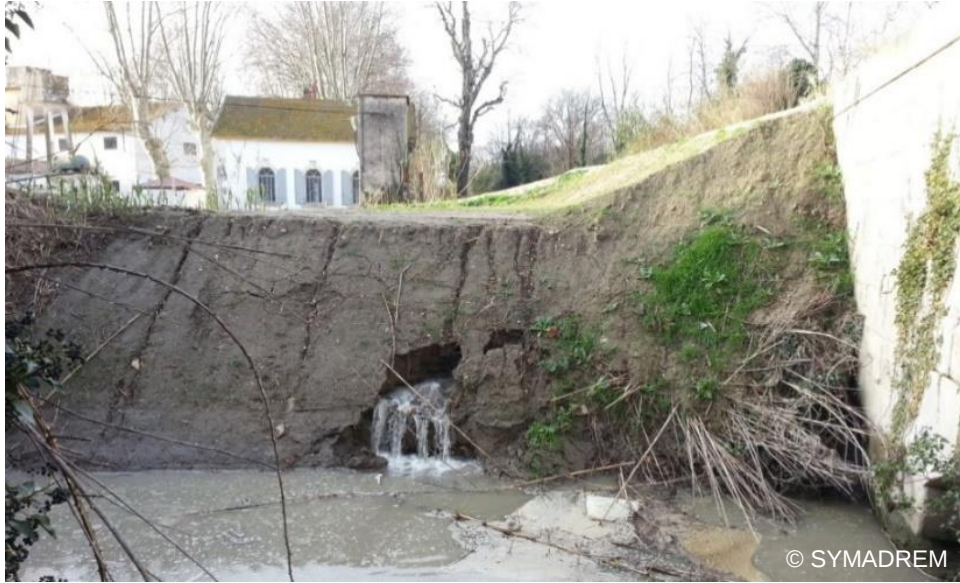
an excessive leakage rate can indicate the imminent initiation of concentrated leak erosion

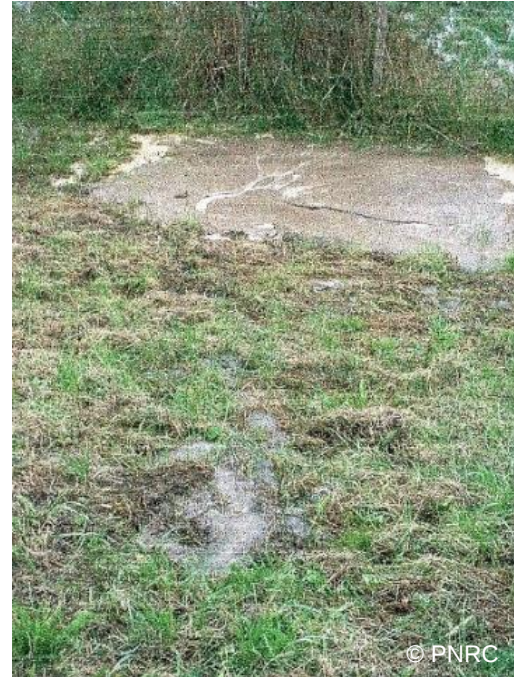
Muddy water seepage or leakage indicates a current internal erosion (mostly in badger burrow or along a crossing pipe)

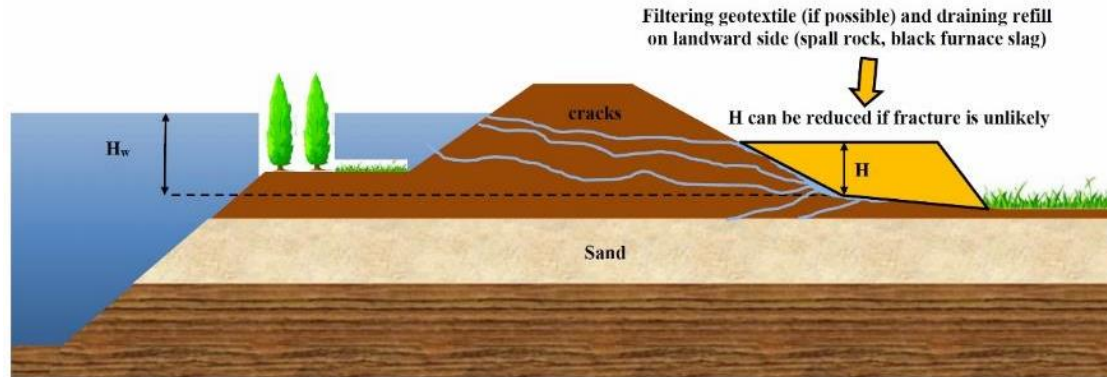
Muddy water seepage

Intervention technique consists of **limiting the flow rate by using highly plastic clay** on the riverward side and using a filtering geotextile (if possible) on the landward side with a **filtering/draining refill made of non-cohesive materials** such as gravels, black furnace slag or spall rocks. The height of the downstream refill must be sufficient to prevent hydraulic fracture of the berm during a flood.

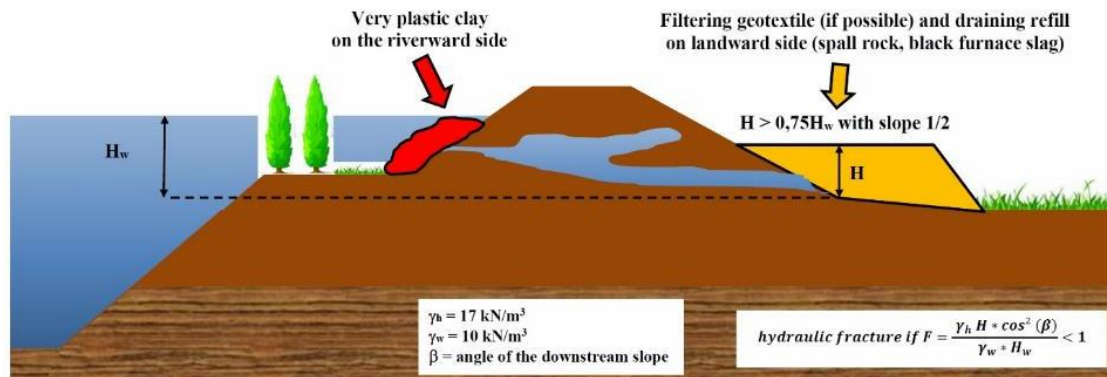
water leakage

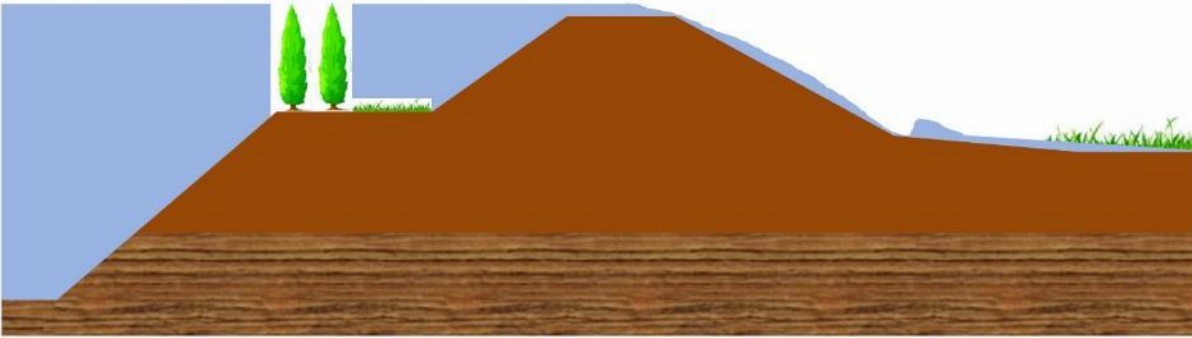
Local overflow or imminent local overflow

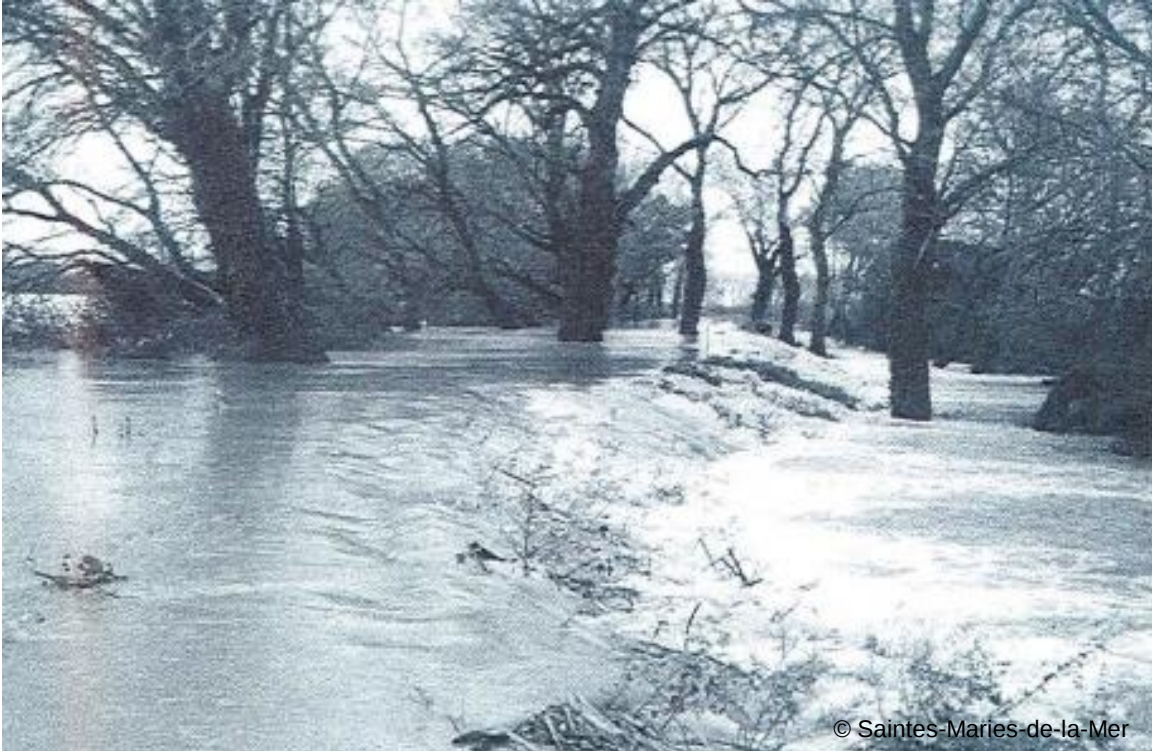
General overflows are not dealt with, given their possible impact on the opposite bank or downstream.

No response
