# WP 3: Reliability of Urban Flood Defences

## Structure Transitions

Report Number: WP03-01-12-10

<b>Title</b>	Comprehensive Report on Action 3.1.2: Structure transitions
<b>Lead Author</b>	Rémy TOURMENT
<b>Contributors</b>	Paul ROYET, Mark MORRIS,
<b>Distribution</b>	Public
<b>Report Number</b>	WP03-01-12-10

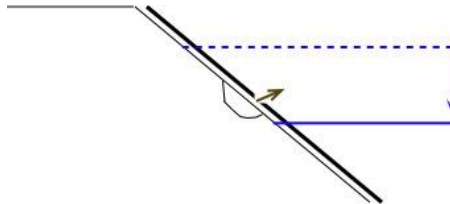
**Figure 1.2 Erosion of the embankment hidden by the protection structure**

In this case the protection structure HIDES erosion instead of avoiding it (Fig 1.1). In a second phase, when the eroded space underneath the protection structure becomes large enough, then the protection structure suddenly fails (through block failure or via whatever units the structure is constructed from).

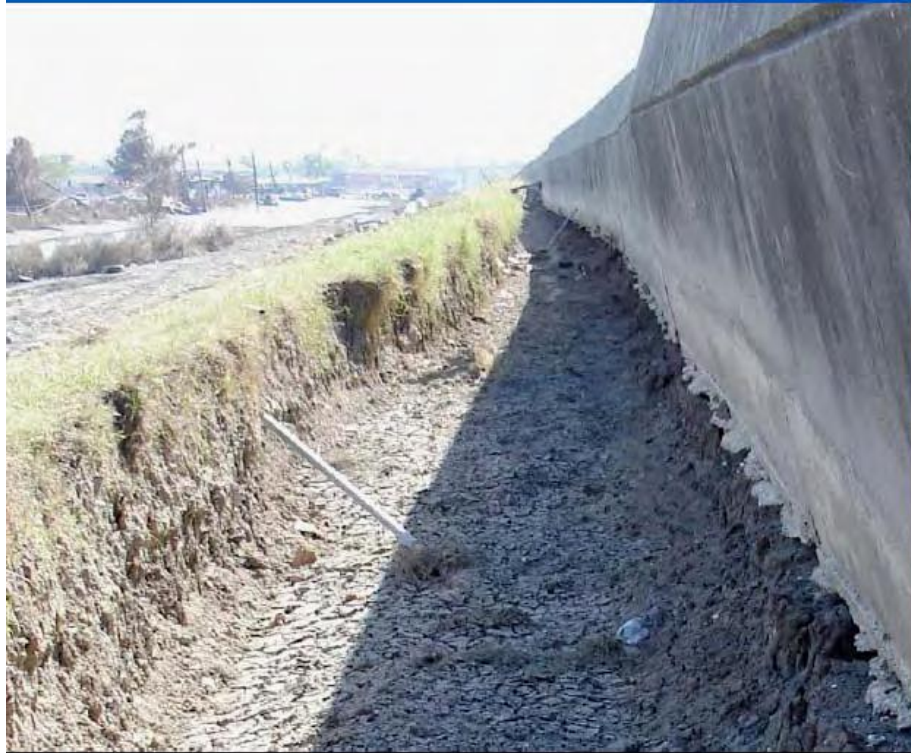
*A common problem observed throughout the flood protection system was the scour and washout found at the transition between structural features and earthen levees. In many cases, the structural features were at higher elevations than the adjacent earthen levee, resulting in scour and washout of the levee at the end of the structural feature. At these locations, the dissimilar geometry concentrates the flow of water at the intersection of the levee with the structure, causing high flow velocities and turbulence that resulted in the erosion of the levee soil. The performance at transitions could be improved by fully embedding the structural walls within the levee fill, and using the levee to transition the difference in elevation from the structure to the main section of the levee. In a few cases, observations indicated that this type of transition performed successfully. The embedded area and the transition to the main section of the levee should have erosion protection such as grouted rip-rap or concrete erosion mats. In some cases, the structures were lower than the connecting earthen levees. At these sites, the flow of the water is channeled over the structural feature, causing erosion of soil on the protected side of the structure. The performance in these cases can be improved by providing erosion protection on the protected side of the structures and along the transition section.*

*Figure: Scour and Erosion on the Protected Side of the IHNC Adjacent to the 9th Ward in the Vicinity of the South Breach*

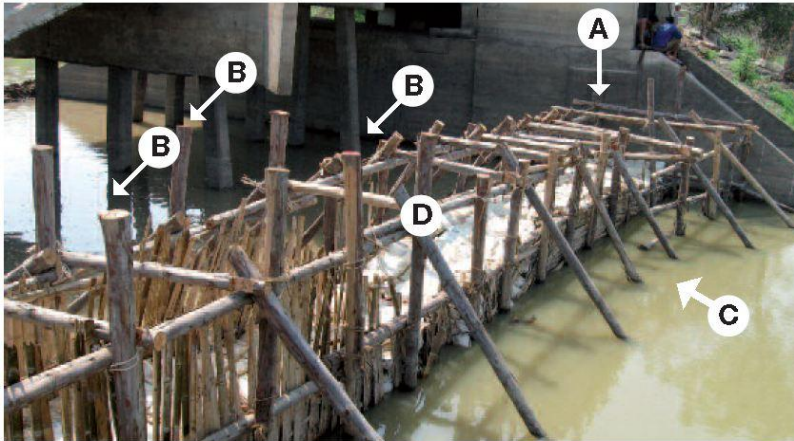
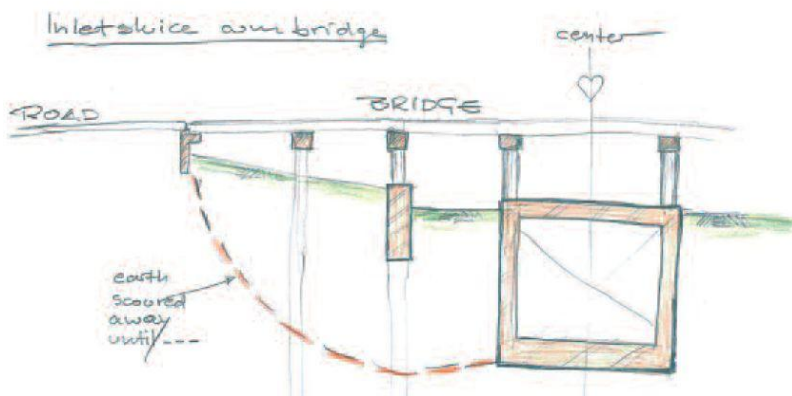
**Figure 3.6 Failure of the Klong Ta Nueng floodgate**

All of the structures that were visited failed at the connection of the structure and the earthen dyke. This indicated how vulnerable these connections are. It was noted that similar observations were made in New Orleans after hurricane Katrina. Since the structures were mainly designed for irrigation purposes with small water heads, provisions to prevent seepage / piping during floods seem to be limited, especially on the connection with the adjoining dykes or dam. Therefore scouring and breaching could occur besides the structures. This is illustrated in Figure 3.6 (Klong Ta Nueng floodgate) and Figure 3.7 (Pra Ngam floodgate), which show a photo of the situation and a sketch of the failure.

**Klong Ta Nueng floodgate**

- A** connection of front wall
- B** soil washed away
- C** flow during flooding
- D** temporary coffer dam

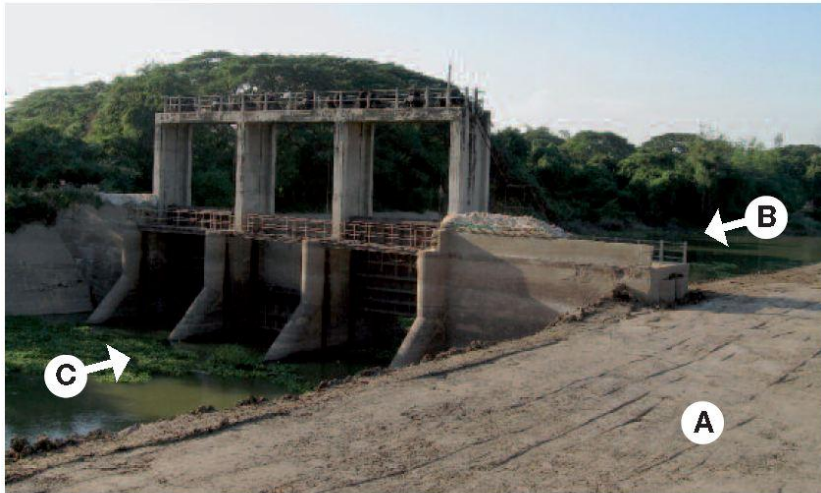
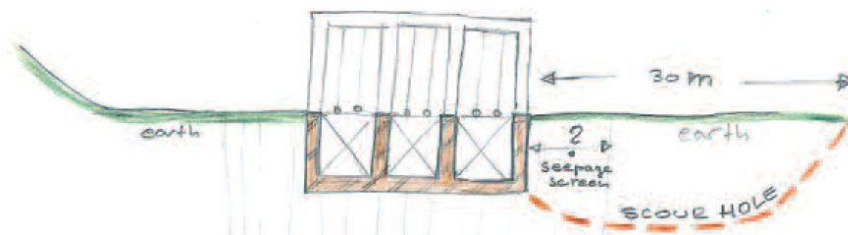
**Figure 3.7 Failure of the Pra Ngam floodgate**

**Pra Ngam floodgate**

INLET SLUICE (Irrigation)  
 crest level increased by sand bags, but connection with earth failed.

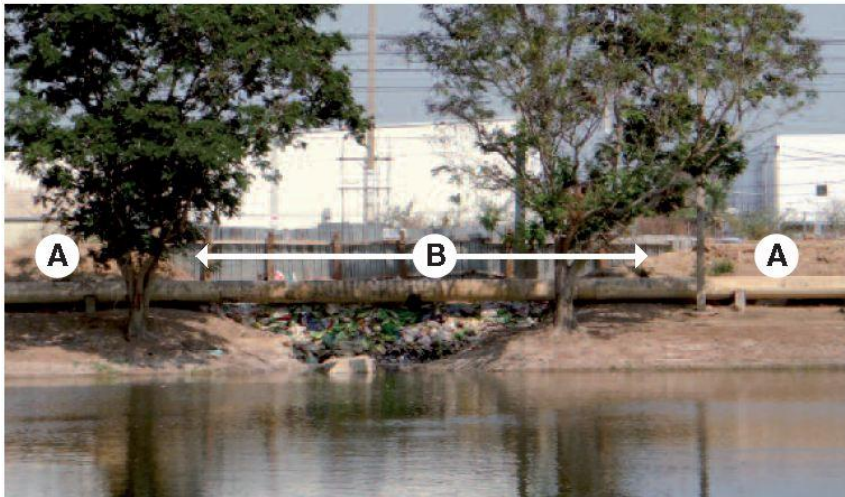
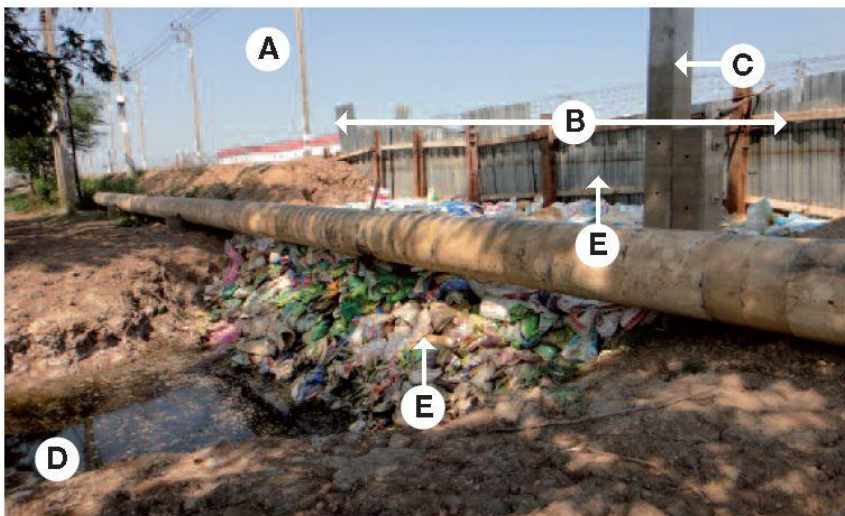
- A** earthen dyke
- B** breach and emergency repair

- A** canal side
- B** breach width ~20m
- C** water mark
- D** protected area
- E** temporary repairs

Figure 3.8 Breach from overtopping; the pipe along the crest may have contributed to the failure

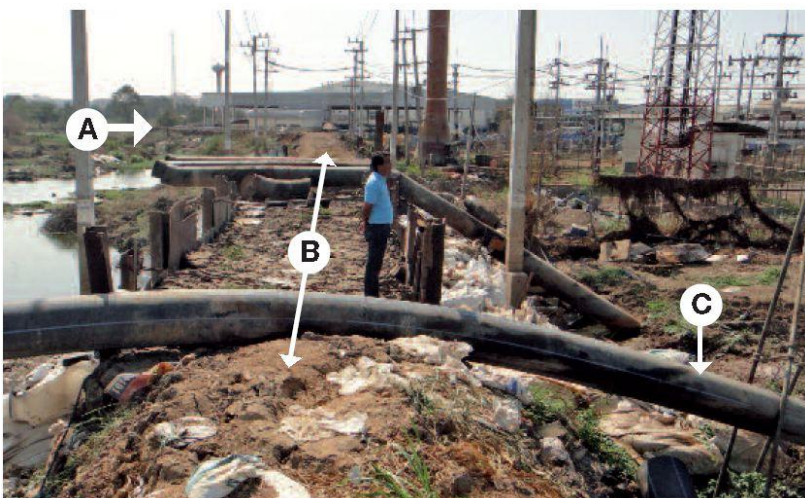
The second breach that was visited occurred at a pipe in the dyke, which was not protected by seepage screens. At this location the failure started with seepage along a pipe through the levee (no seepage screen) and failure progression accelerated when it was also overtopped. According to eye witnesses it took about 2 hours to form the 30 wide breach. The levee was rather new and built after floods in 1999. (See Figure 3.9).

- A** overflow direction
- B** breach width ~30m
- C** relocated pipe (through levee without seepage screen before)

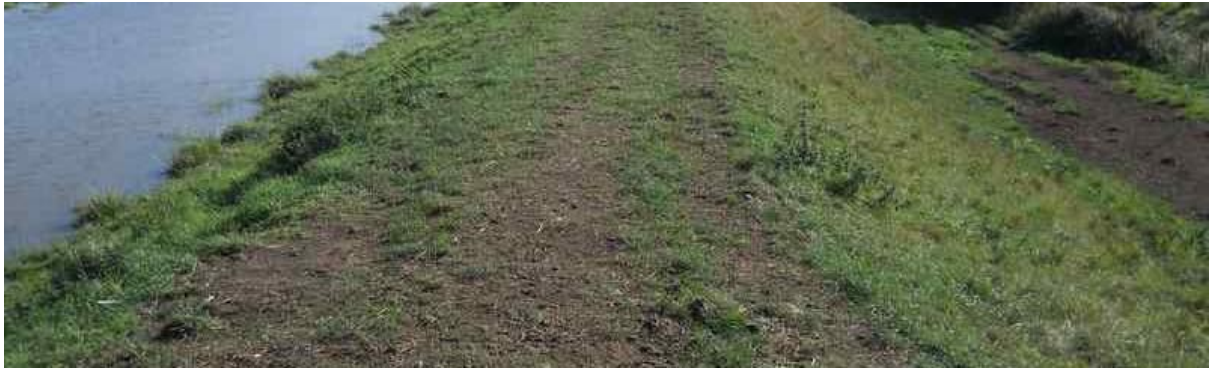
**Figure 3.11** Bare soil on the embankment crest

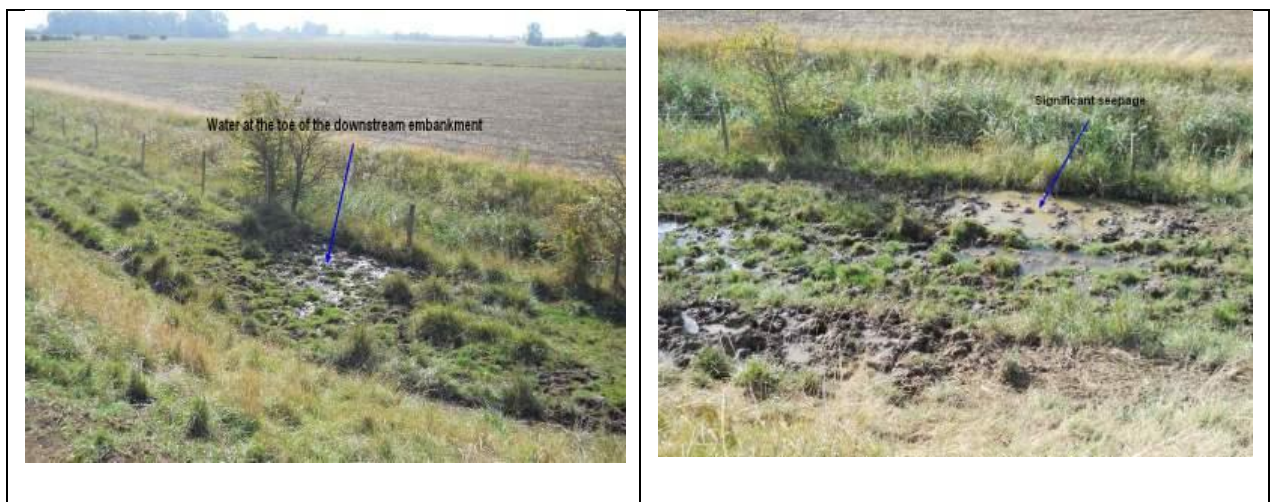
**Figure 3.13** Seepage at two locations along the embankment in Winterringham

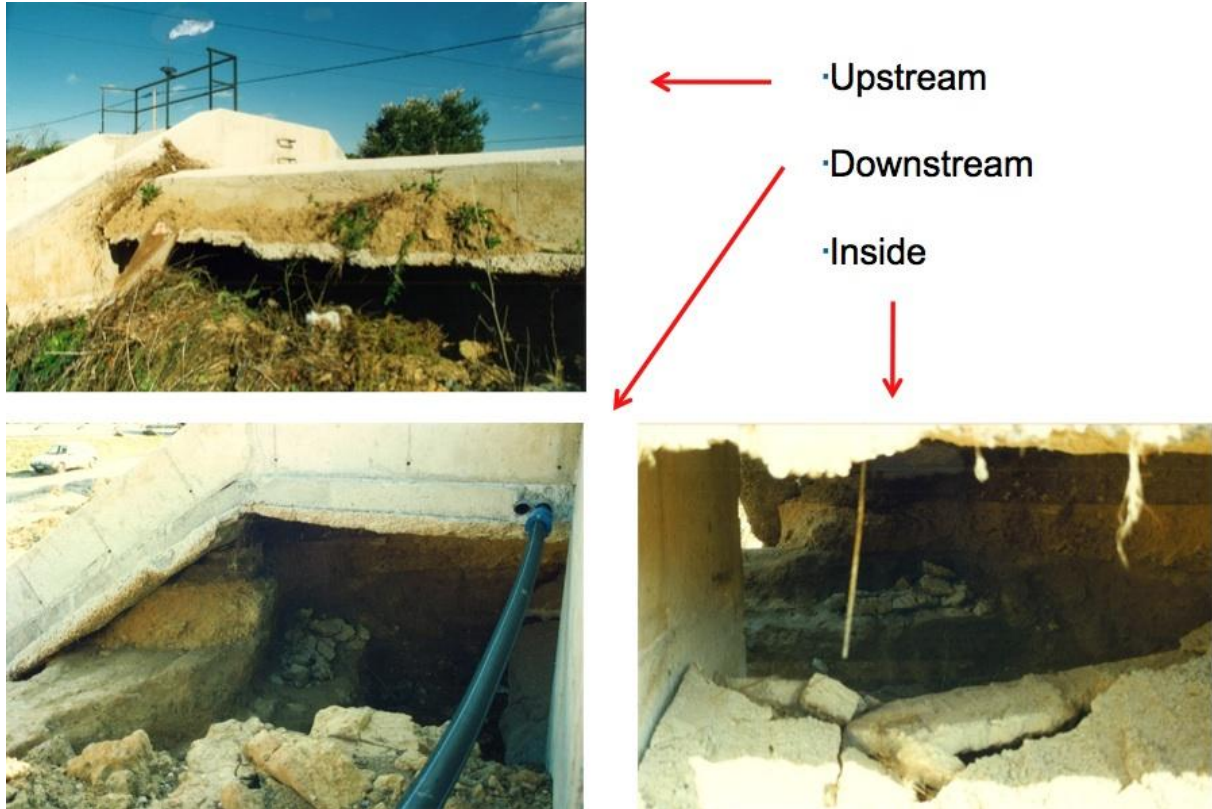
**Figure 5.3** Erosion along a safety weir wall, and under its crest (Aix en Provence)

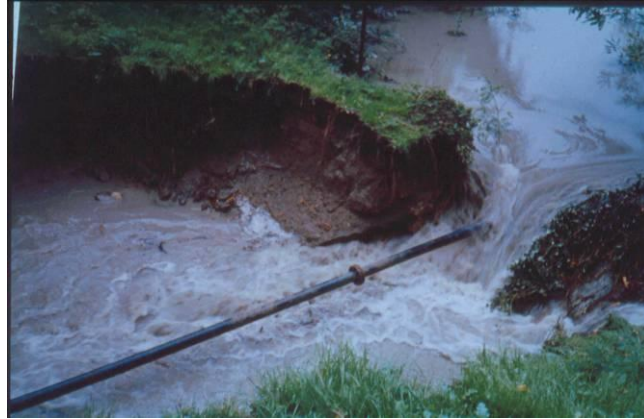
**Photo 5.6** Levee breach initiated along a pipe crossing (Rhône River). Photo SNRS.

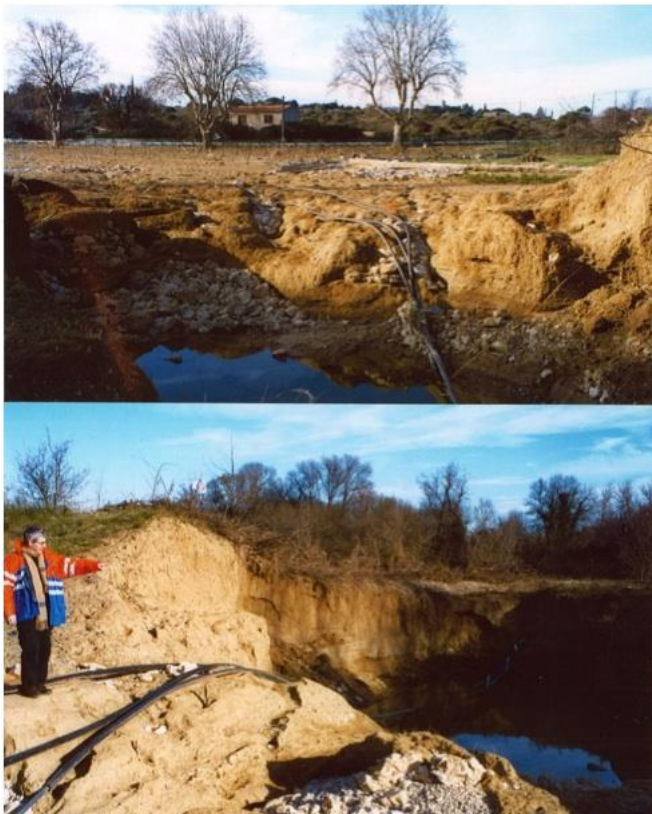
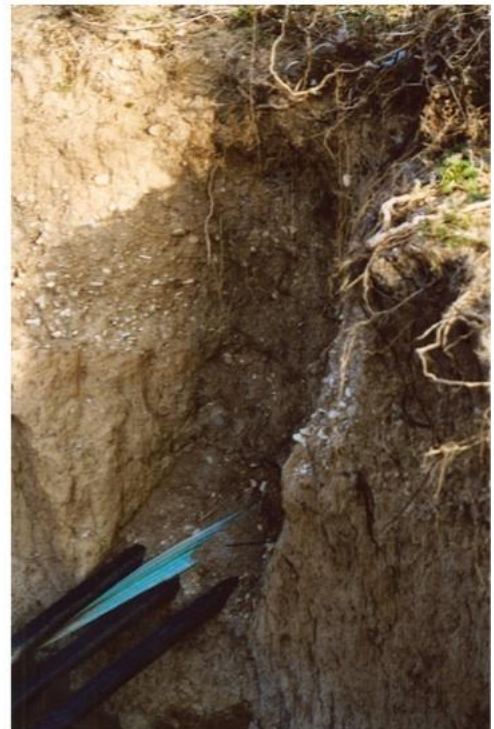
The following set of pictures shows a breach which was probably caused by erosion around some telecommunication cables: in the picture on the right, it can be seen that the cables were put in a trench filled with coarse and non cohesive material which would act as a preferential seepage path. The trench can also be seen on the upper left picture, on the left of the set of cables (just under the house).

**Figure set 5.5** Breach initiated along crossing cables (Mosson River, winter 2002-2003).

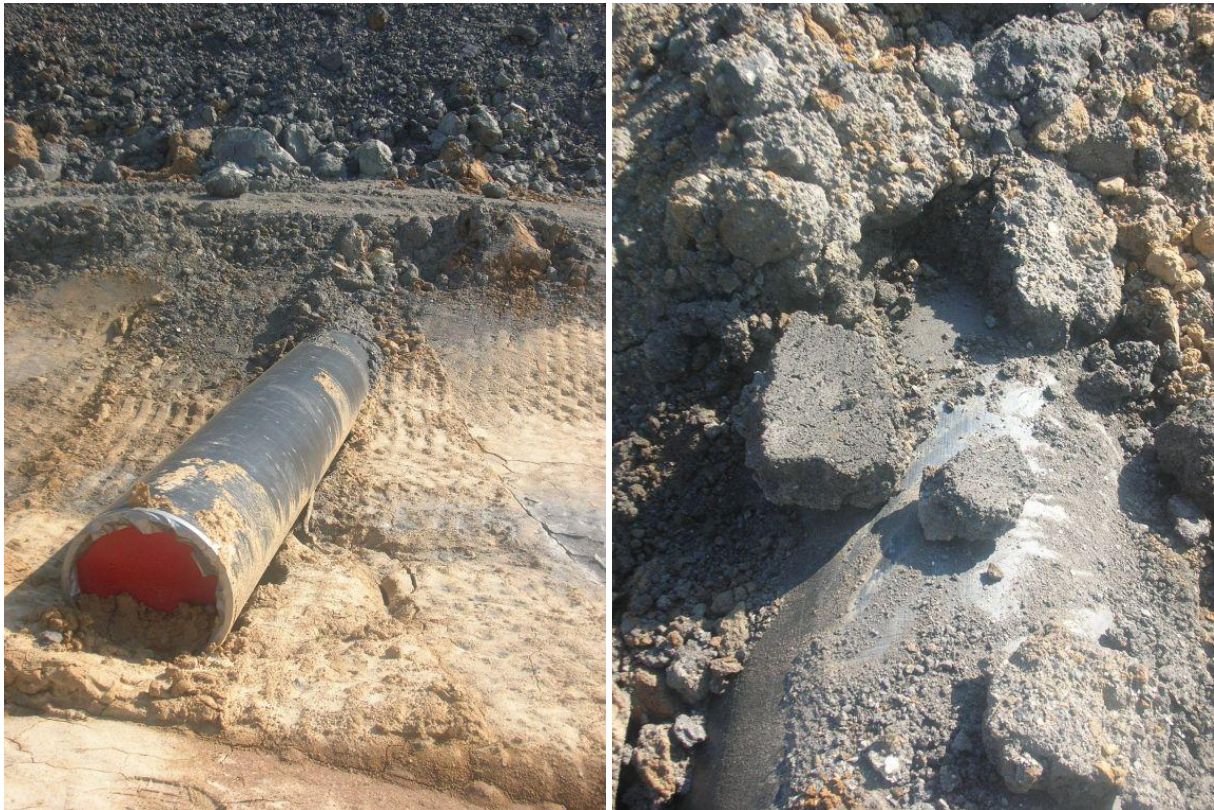
The following set of pictures shows a pipe which is crossing under the base of a levee with no specific treatment of the contact surface visible, and hence the strong possibility of contact erosion

**Figure set 5.6A** pipe crossing at the base of a levee (Dresden)

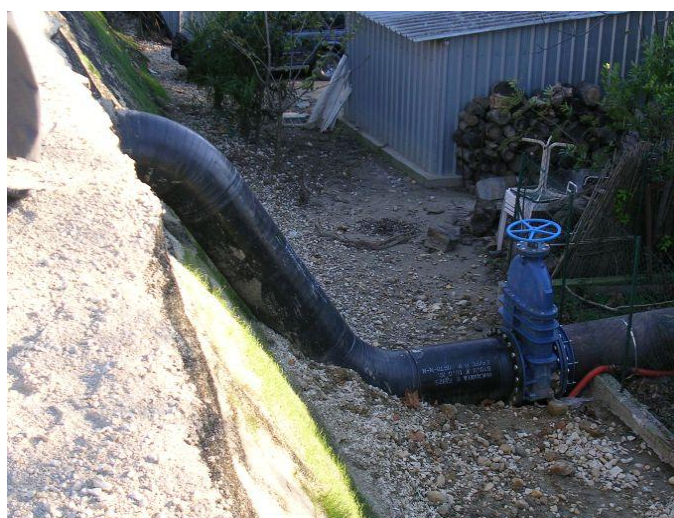
**Photo 5.7** A crossing pipe with " siphon shape" (Rhone River), to minimize the risk of internal erosion along the pipe. Picture of the land side of the levee.

The next picture presents a solution (adopted as general design by SYMADREM, Rhone River levee management organisation, for retrofitting older pressure pipes), as it lengthens the contact area, and removes most of it at the point of highest gradient.

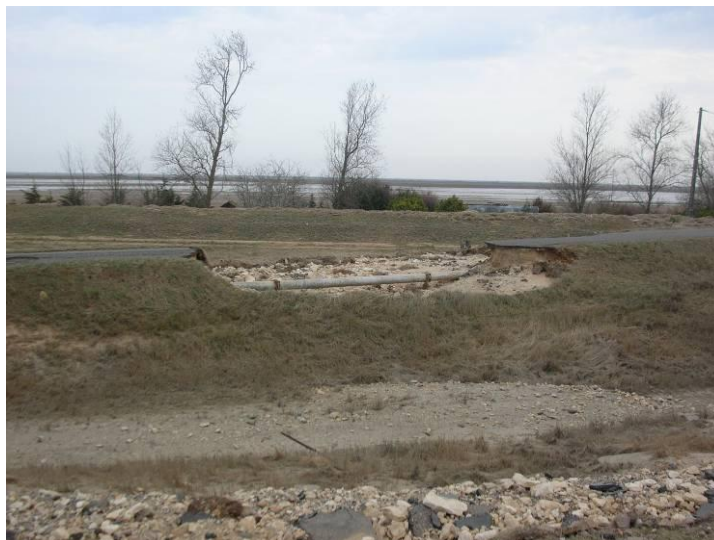
**Photo 5.8** Breach of a coastal levee (Vendee, France) exposing a longitudinal pipe

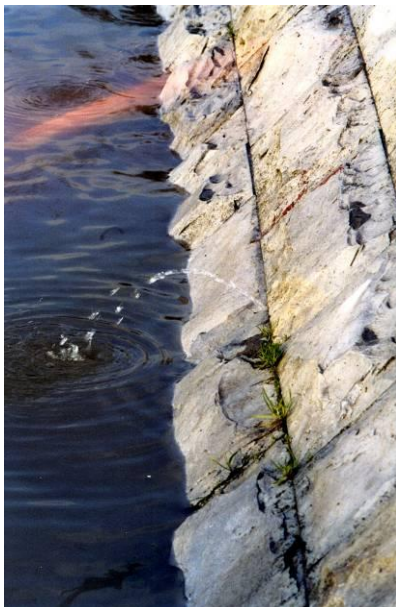
**Photo 5.9** A leak through the joints of a masonry revetment, after a flood. This can lead to erosion behind the masonry (Arles, France).

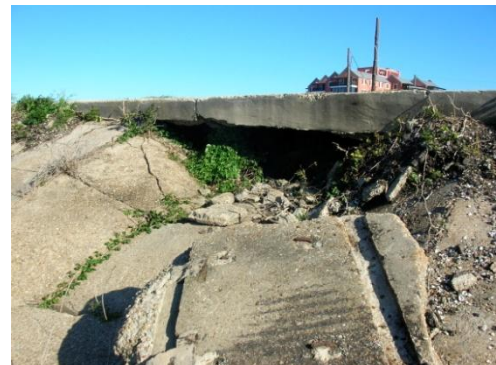
**Photo 5.10** Failure of a levee caused by erosion underneath the revetment followed by the collapse of the revetment (Algiers, New Orleans, USA)

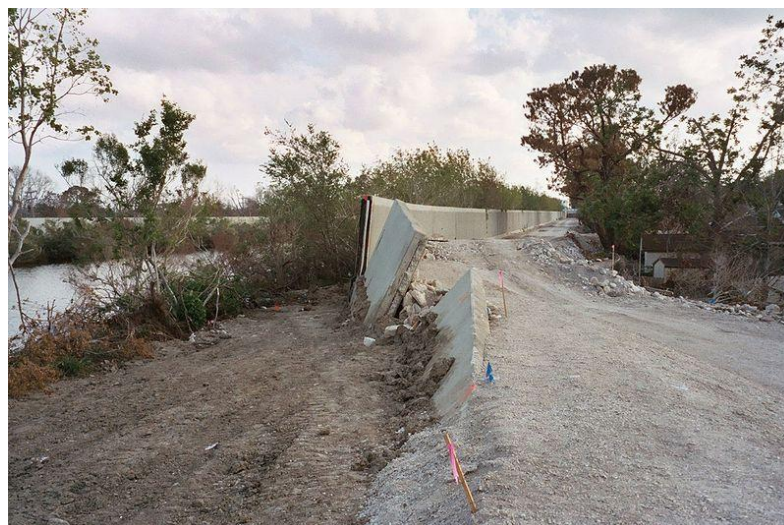
When Hurricane Katrina struck New Orleans in August 2005 extensive flooding occurred, with levee breach occurring in a number of places. One of the mechanisms of failure that occurred was the failure of wall sections constructed on top of and integrated into the levees. See Section 3.2 of this report for more details and examples.

Photo 5.13 New Orleans, London Avenue Canal (Photo: [www.online-utility.org](http://www.online-utility.org))
