Detection of cavities in levees and forelands caused by beavers (1) & mitigation measures (2)

EUCOLD WG Levee & Flood Defences - Workshop
June 30, 2021

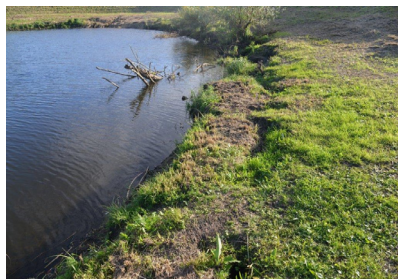
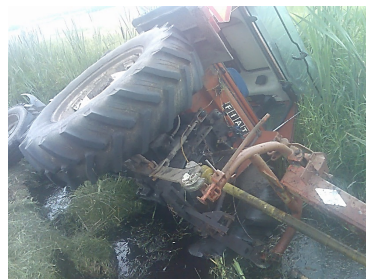
- Cavities (tunnels, tunnel systems, dens) and surface damages at
 - River banks → erosion and sediment input
 - Foreland → danger to river maintenance works
 - Levees (on water- and landside) → reduced reliability → risk increase

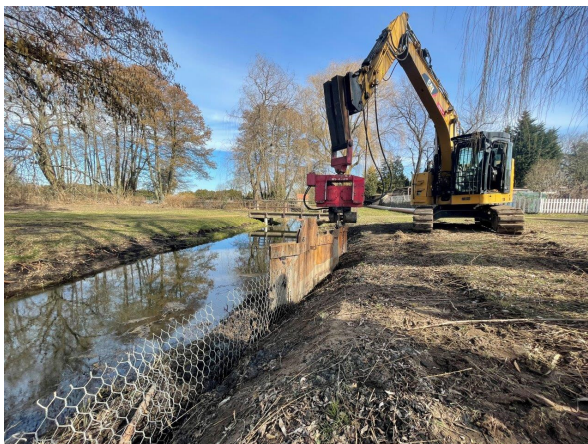
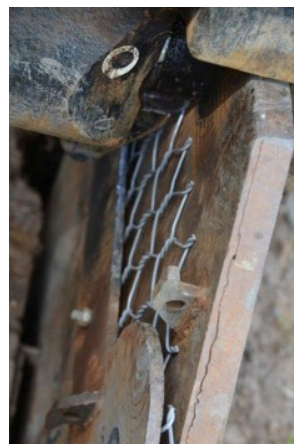
Vertical Barriers – trenchless netting installation

- Flexible netting installed without trench using sheet pile technique

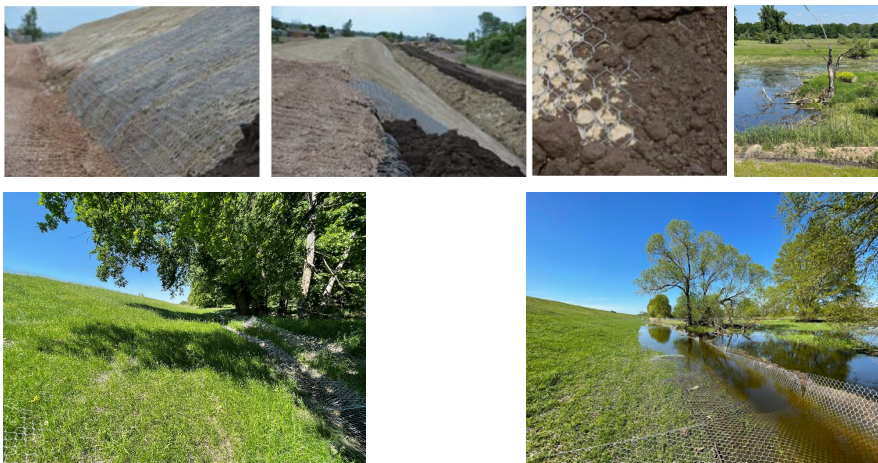
Near Surface Barriers

- Flexible netting covered with top soil after installation

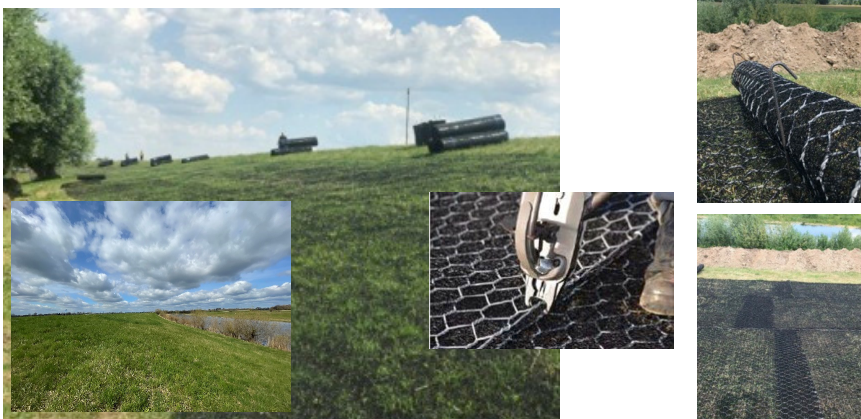
Near Surface Barriers

- Flexible netting + integrated erosion mat fixed directly on existing vegetation
→ increased erosion resistance (overtopping)

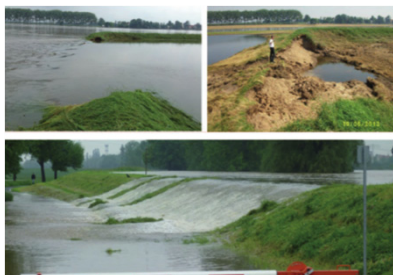
Near Surface Barriers

- Flexible netting + integrated erosion mat fixed directly on existing vegetation

- resistance against overtopping:

5,5 - 4,3 m/s (< 24 h)
4,3 - 3,7 m/s (< 48 h)
3,7 - 3,2 m/s (> 48 h)

- 3-times higher compared to grass vegetation without reinforcement

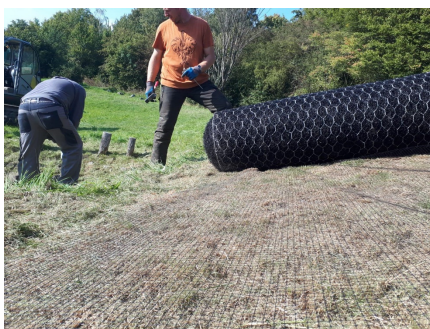
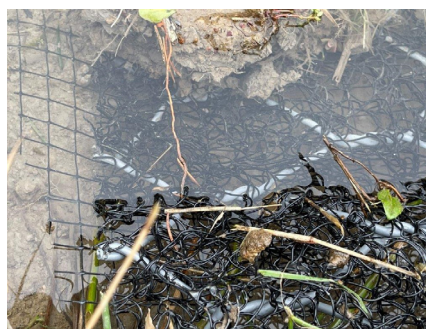
Near Surface Barriers – Small Rodents

- Flexible netting + geosynthetic grid with small opening size underneath

- Geogrids with small openings as “add on” to steel mesh solution to prevent levee infestation by small rodents
- hybrid solution nominated for the “German Economy Innovation Award” in 2020
