Issue 11 - December 2023

LEVEES Working Group NEWSLETTER

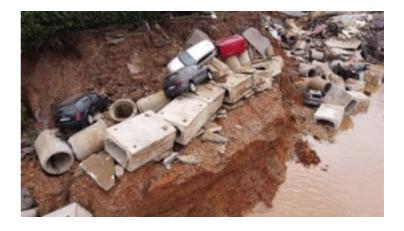
Picture 2: Flood damage in Erftstadt Blessem (Source: <u>https://rp-online.de/</u>)

In 2021 a devasting flood struck Europe. During 13th and 15th July 2021 a low-pressure front named "Bernd" (picture 1) moved relatively slowly across France, via Belgium through Germany to East Europe. In France, Belgium and Germany major floods resulted from the occurring heavy precipitation. The floods developed fast, thus, those floods could be defined as "flash floods" (Dallmeier, 2017) for which the development period is less than 24 hours. In Germany 188 fatalities are documented of which 135 were in the county of Ahrweiler where the river Ahr is located. The financial damage announced by the insurer Münchner Rück reached 46 billion Euro in total and, exclusively, 33 billion Euro in Germany and was, by these numbers, the second biggest natural disaster ever regarding insurance damage (see also picture 2).

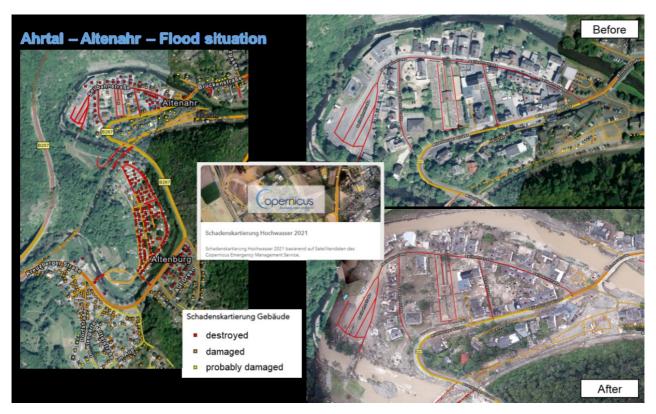
Figure 3: Documented flood damages at the Ahr within vicinity of the villages Altenburg and Altenahr

The impact of the flood was evaluated after the flood, e. g., by the Copernicus Emergency Management Service. In figure 3 the Ahr river loop in the vicinity of Altenburg and Altenahr is shown including documented damage spots (left). The picture on the right provides a comparison between the situation before and after the flood for the village Altenahr. The flood did exceed the existing riverbed and embraced the settlement area so that the people were trapped between two flood streams.

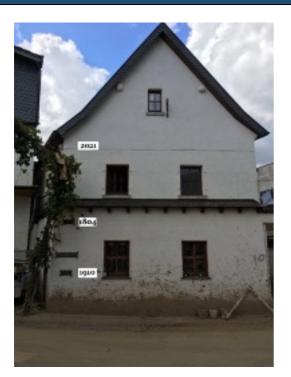
Picture 5: Flood marks at a house in the village Dernau (Source: Mr. Matthias Habel, see also Roggenkamp, 2021)

Natural hazards such as floods are not the primary cause for fatalities or damage. The primary cause is the infrastructural and urban developments which increases the vulnerability of affected areas, critically. This fact is documented by flood marks at a house in the village Dernau where the water level reached the first floor during the flood event 2021 (picture 5).

The house was already existing in 1804 but the flood level was much lower in spite of similar discharges. In the year 2016 the flood did only exceed the pavement elevation in front of the house and affected the basement which also led to the fact that many inhabitants evaluated the upcoming flood risk in 2023 critically wrong.

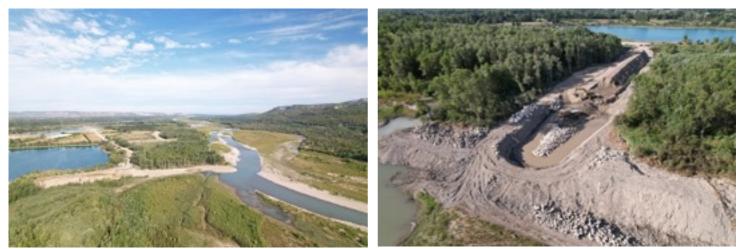
Works to set back and lower the groynes of the Carriers dyke

The construction work, which began in the summer of 2023, mainly consists of reducing the hydraulic impacts of the groynes that have, until now, caused a significant increase of water level during floods: retreat of the heads of the groynes, lowering and strengthening of their linear parts. These operations make it possible to guarantee a comfortable margin before overflow on the main levee which is the subject of fairly limited work like slope adaptation of the embankments and installation of filtration devices. The risk of breach will thus be controlled up to the 100-year flood and very low up to the exceptional flood (about 500-1000 year). A safety spillway is installed upstream of the protection line, in an area where the elevation between the upstream and the downstream lands is particularly low. The overall protection level (preventing water entry into the protected zone) will be equivalent to the 5000 m^3/s centennial flood. Beyond that, the system has been designed to avoid a major structural failure until the exceptional flood of 6500 m³/s exceptional flood.
