**WEBINAR MARCH 16<sup>TH</sup> 2023**

**EMERGENCY WORKS  
ON THE RHÔNE DELTA LEVEES  
INTERVENTIONS PRINCIPLES  
&  
FEEDBACK ON RECENT FLOOD  
EVENTS FROM 1993 TO 2016**

**THIBAUT MALLET  
SYMADREM, FR**

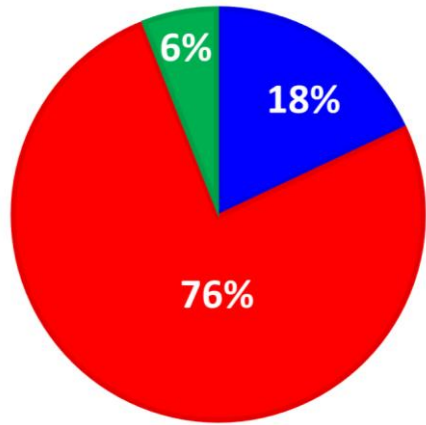
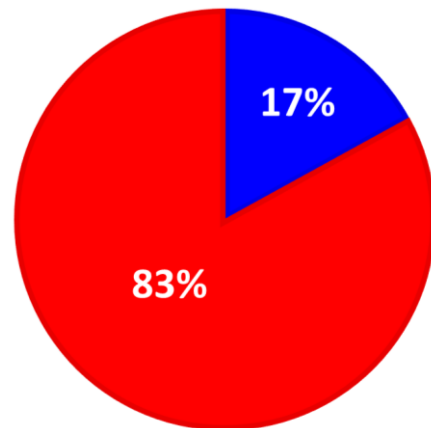
**57 breaches (with inundation) and 57 breaches in progress (no inundation)**

Internal erosion => **concentrated leak erosion**

80 % in badger burrows

Breaches and breaches in progress

■ overflowing ■ internal erosion ■ scour

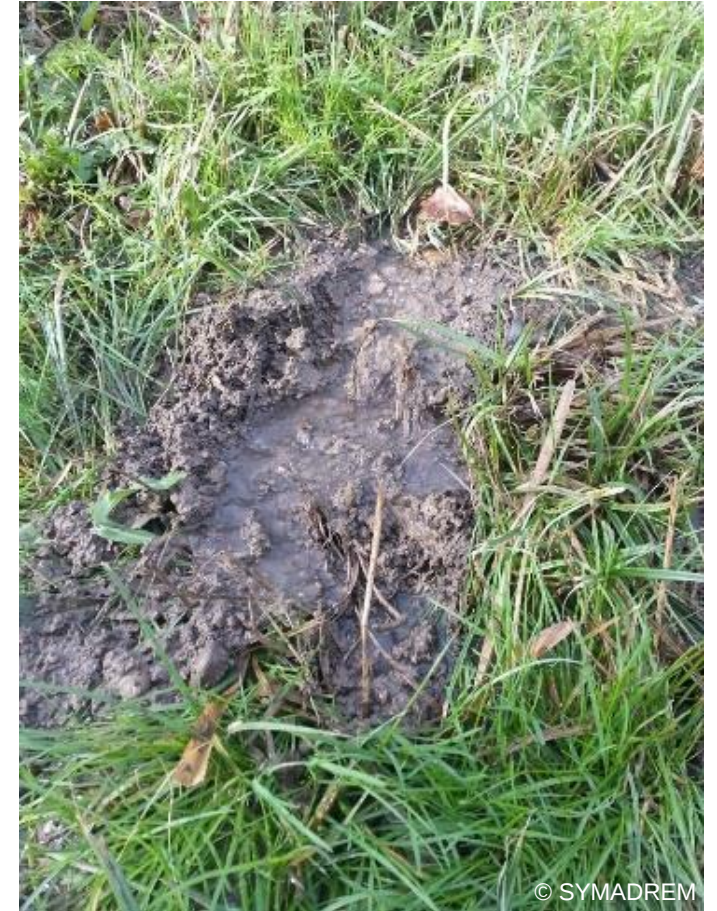
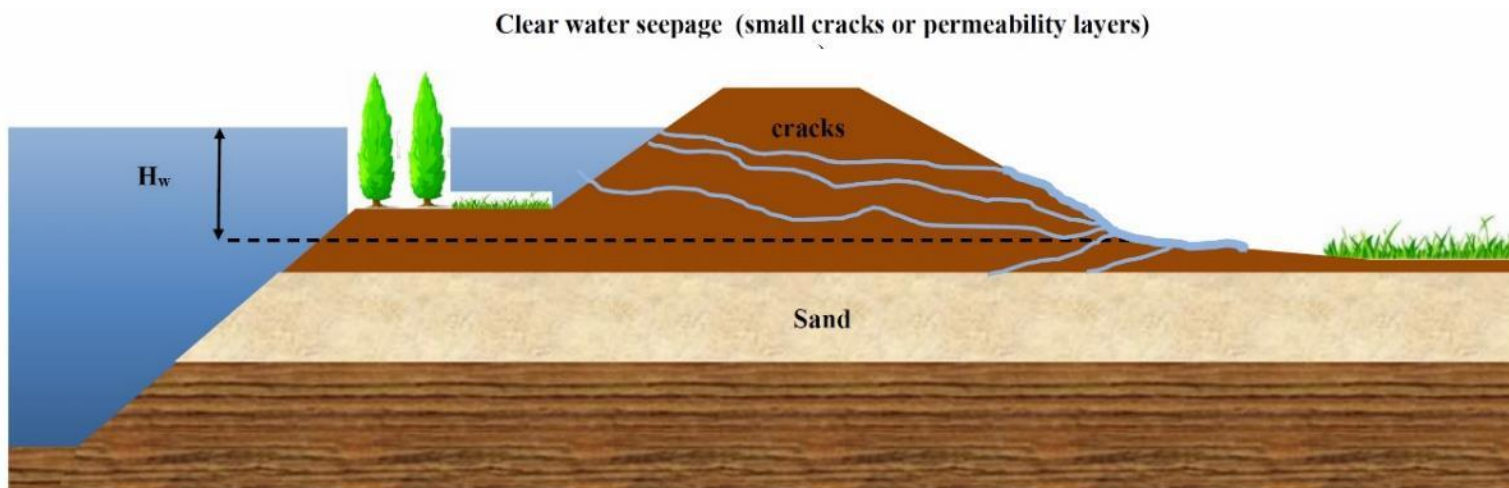
Clear water seepage is fairly common during floods...

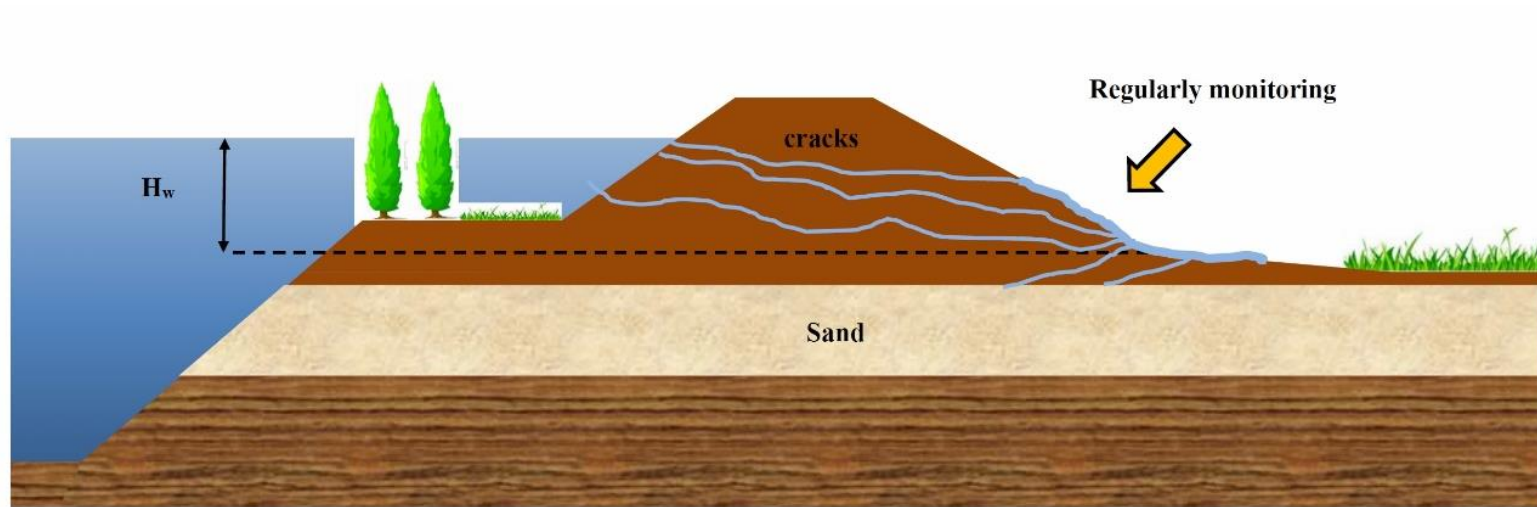
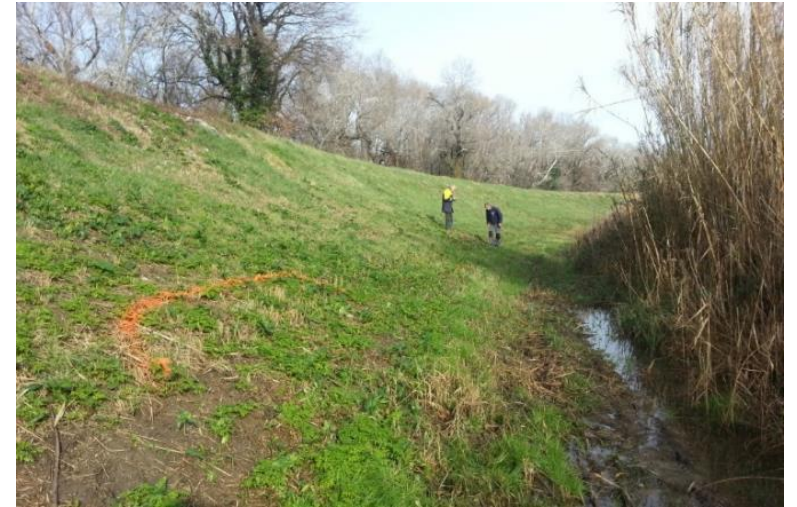
# RESPONSE TO CLEAR WATER SEEPAGE IS REGULARLY MONITORING

and most of the time, levee is monitored regularly

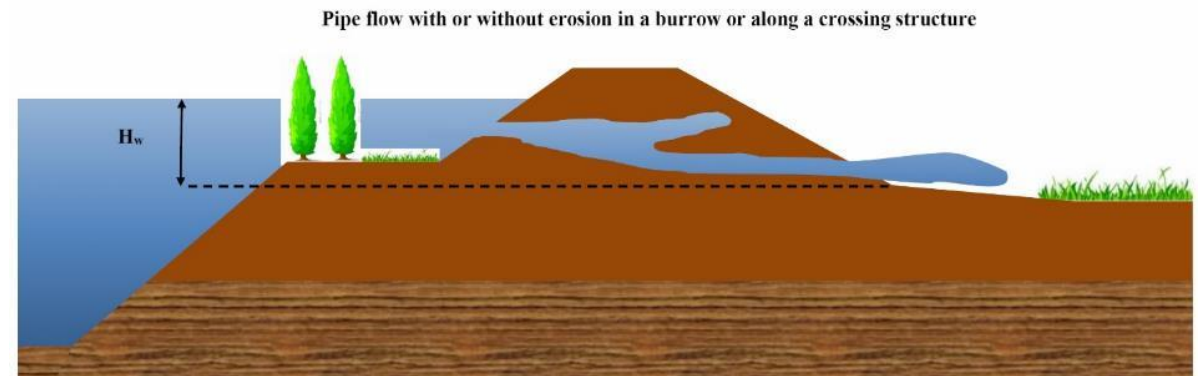
Muddy water seepage or leakage indicates a current internal erosion (mostly in badger burrow or along a crossing pipe)

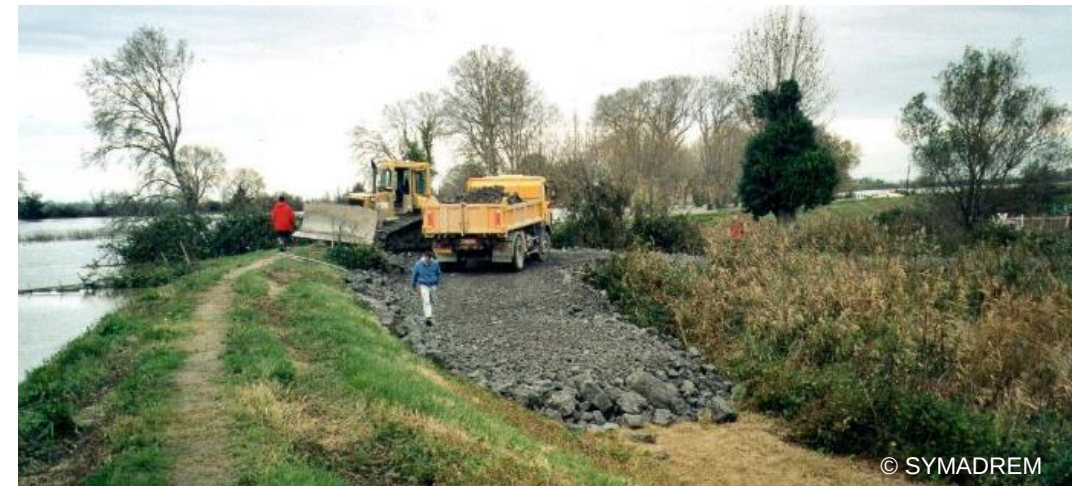
Muddy water seepage

water leakage

Intervention technique consists of **limiting the flow rate by using highly plastic clay** on the riverward side and using a filtering geotextile (if possible) on the landward side with a **filtering/draining refill made of non-cohesive materials** such as gravels, black furnace slag or spall rocks. The height of the downstream refill must be sufficient to prevent hydraulic fracture of the berm during a flood.

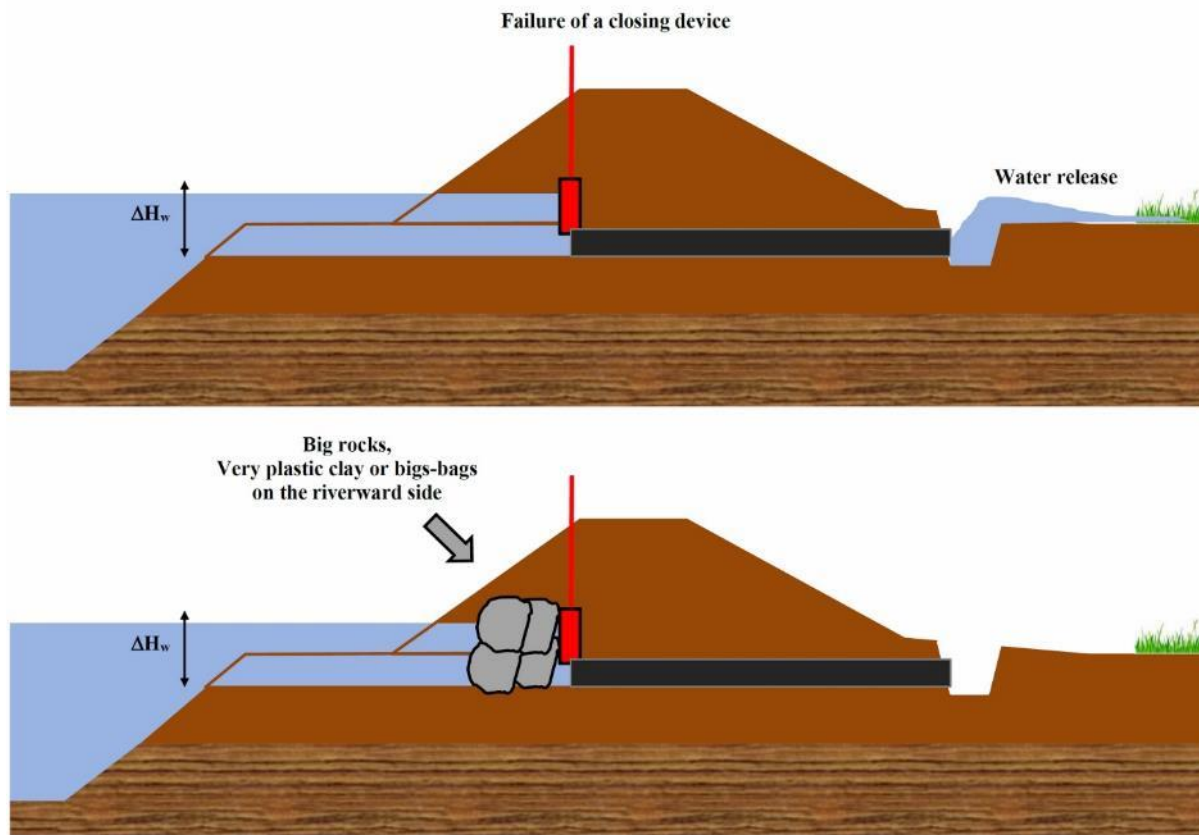
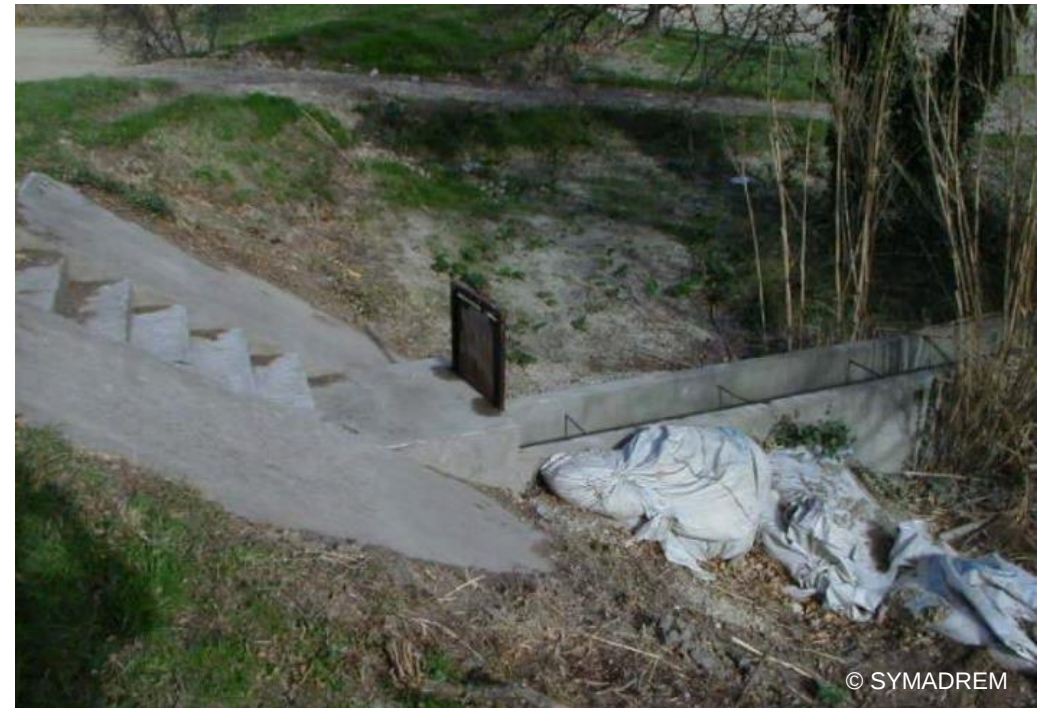
## INTERVENTION IN CASE OF NON-CLOSURE OR FAILURE OF A CLOSING DEVICE

Works are preferentially carried out on the riverward side using blocks of 3 to 6 tonnes (given that speeds can reach 7 m/s) or equivalent big-bags.

The block size distribution is reduced if the speed is lower.
