# WP 3: Reliability of Urban Flood Defences

## Structure Transitions

Report Number: WP03-01-12-10

<b>Title</b>	Comprehensive Report on Action 3.1.2: Structure transitions
<b>Lead Author</b>	Rémy TOURMENT
<b>Contributors</b>	Paul ROYET, Mark MORRIS,
<b>Distribution</b>	Public
<b>Report Number</b>	WP03-01-12-10

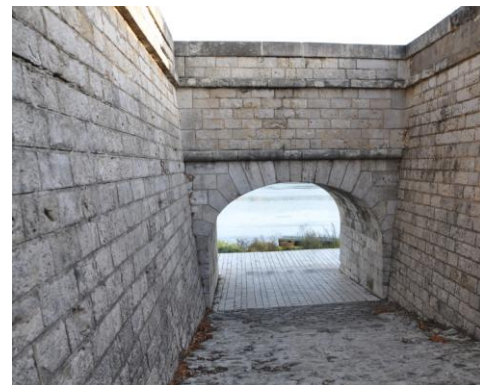
Figure 3.1 Jargeau's gate

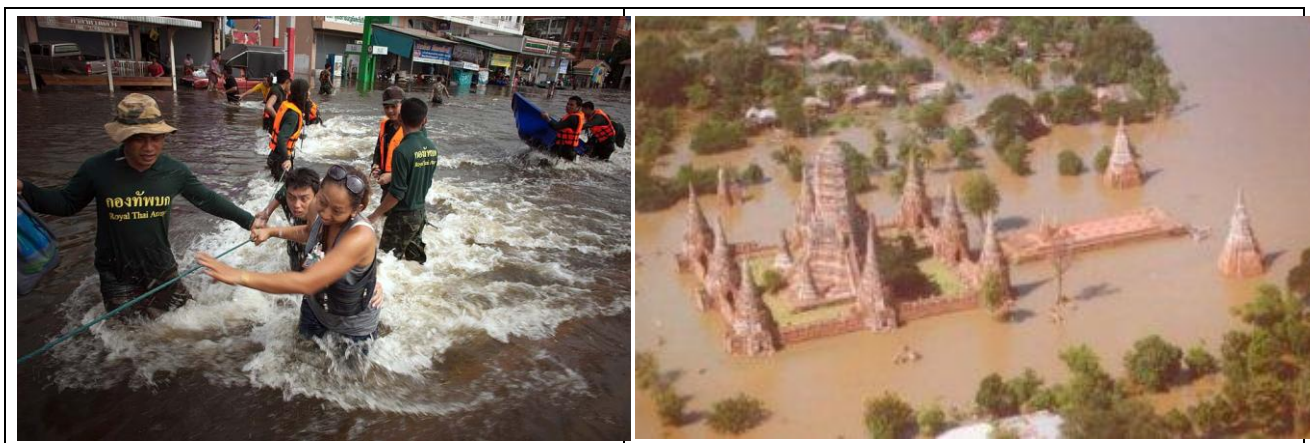
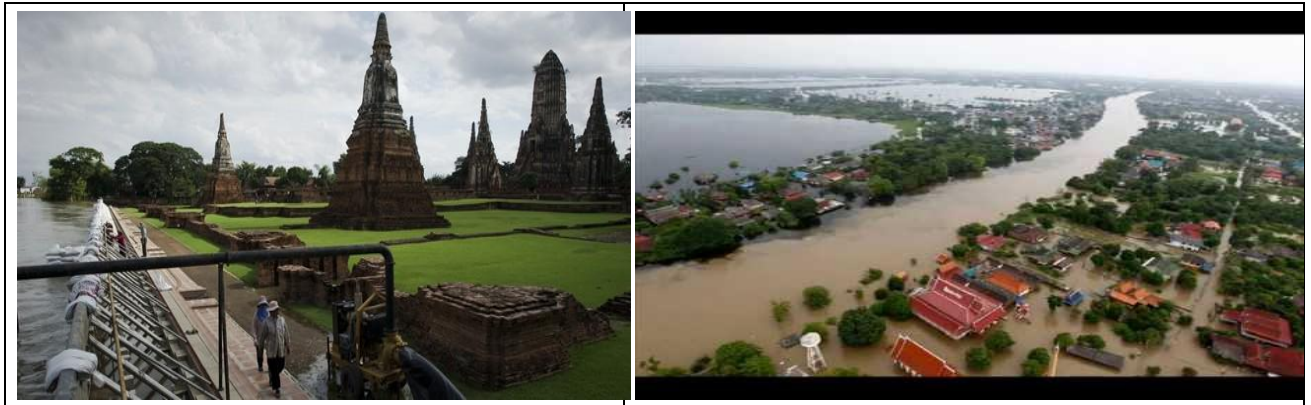
The Lower Chao Phraya river basin is a complex network of rivers, canals and streams (Figure 3.4). The maximum discharge capacity in the lower part of the basin ranges from 2750 m<sup>3</sup>/s to 3500 m<sup>3</sup>/s. During the 2011 floods Thailand was struck by one of the most devastating natural disasters in Thailand’s modern history. Sixty five out of seventy seven Thai provinces were subject to flooding along the Mekong and the Chao Phraya river basins. The flooding persisted in some areas for months and resulted in more than 800 deaths and 13.6 million people being directly affected (Figure 3.5).

**Figure 3.5 (i) Flood evacuation; (ii) Historical sites flooded; (iii) Temporary flood defences; (iv) Widespread flooding**

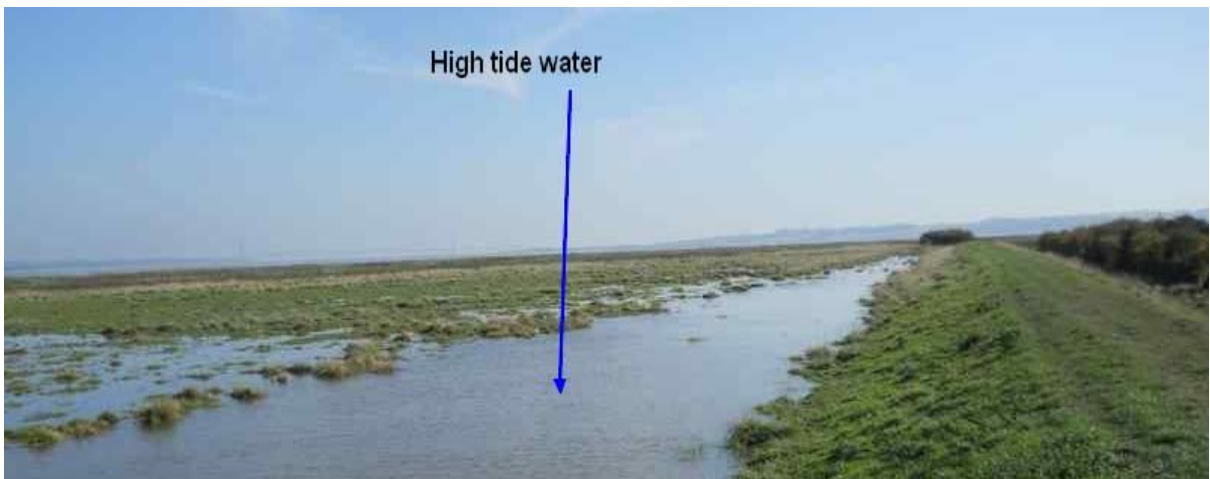
The bulk of the flood defences along the estuary are earth embankments, but with varying degrees of revetment protection and added structures (see below). Typical problems for managing the defences include erosion and seepage (see Figures 3.11, 3.12, 3.14). The tidal range can be very large, resulting in occasions where the flood defences appear set back from the water by a considerable distance (Figure 3.15).

**Figure 3.12** High tide water in Winterringham site

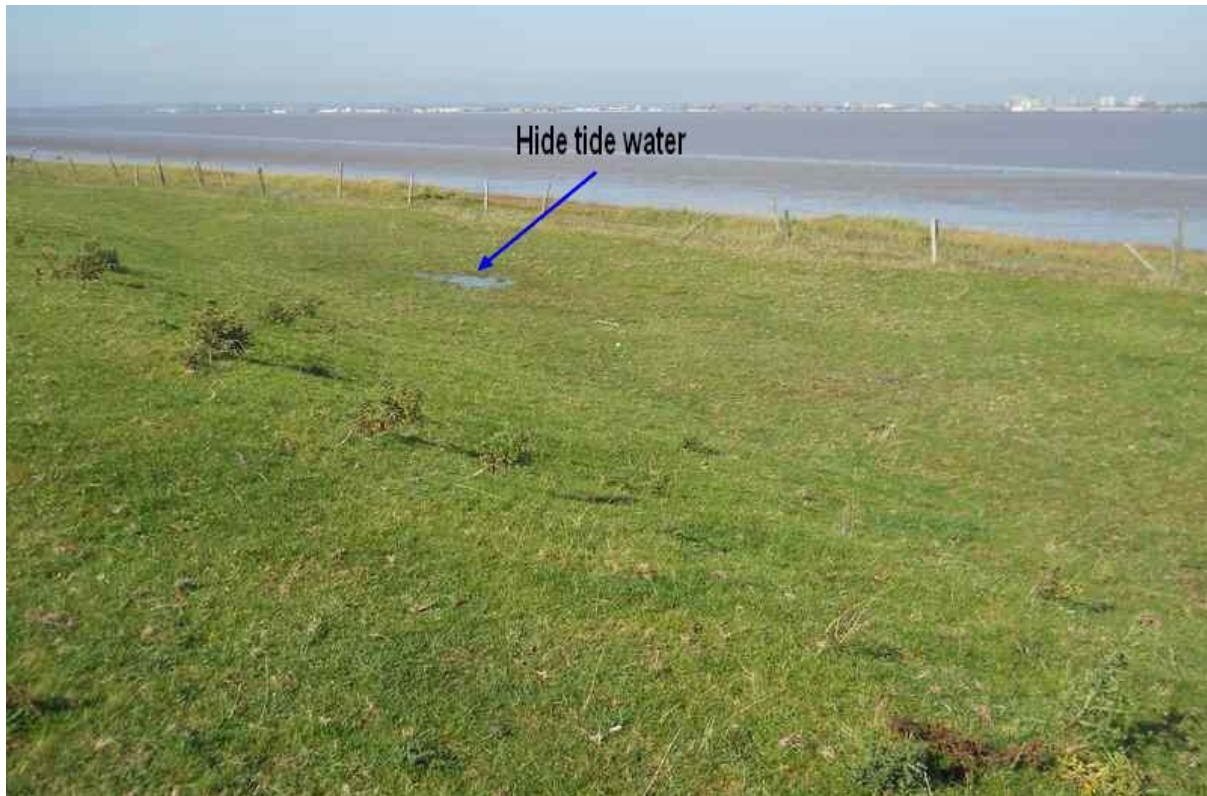
**Figure 3.14** Remnants of high tide water in front of the embankment
