# LEVEES Working Group Newsletter

## Note from the Chairman

By **DAVY DEPREITER**, Flanders Hydraulics Research, Belgium with **Jeroen Vercruyse**, Patrik Peeters (Flanders Hydraulics Research, Belgium), **Leen De Vos**, Ivana Vukotic Hiskjere (Geotechnical Division Flemish Government, Belgium), **Timothy Saey** (3D-Soil BV, Belgium) and **Tinne Michielsen** (De Vlaamse Waterweg NV, Belgium).

A 20 km long 25 m wide levee situated in between two parallel discharge canals (and surrounded by 2 outer levees) in the northwest of Flanders, Belgium, has failed late 2018 for a reason unknown, yielding a breach of 25 m long. The canals and levees date from the 1860-1870'ies and are characterized by parallel rows of poplar trees, yielding a striking landscape feature. After repairs in 2019, a multidisciplinary study was conducted in 2020-2021 to identify drivers of the failure and prevent future events.

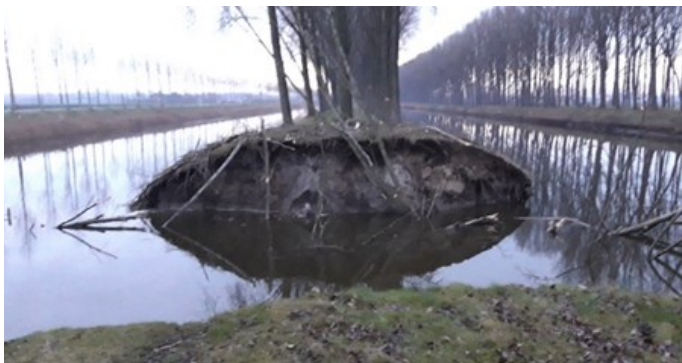
Figure 4: Breached central levee, end 2018.

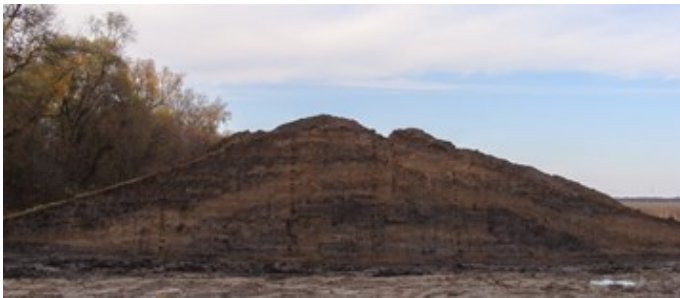
Figure 8: Cross-section of the levee, with visible layers (section 74+902 km)

Hungary has a 4400 km long primary flood protection system. Overall, 92,9 % of these levees are made of cohesive soils. The construction of the dike system began in the 19th century along with the Tisza river regulation works. The soils used to construct the levees were built in at high water content, and proper compaction methods were not in practice back then. Over the decades, rivers became surrounded by dikes, the area of the natural floodplain was reduced, and the floods were peaking at higher levels. The hydrological cycle has become extreme in recent decades due to climate change. Heavy rains and floods are followed by extreme droughts. The levees in the past hundred years have been raised many times. As a result of heightening and strengthening, a heterogenous onion structure was created. This dike evolution is visible in Figure 8. Along river Tisza, northeast of Szolnok, a longer dike section was relocated further away from the river to give way to the floods. In consultation with the contractor, the levee cross-section was excavated in three places for investigation.

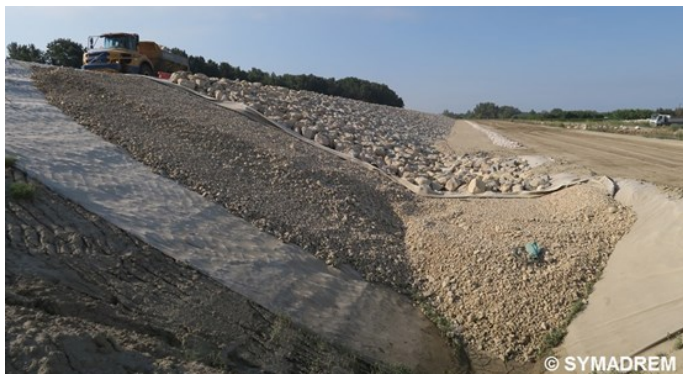
Figure 10: Cross section of the levee resisting to overflow between Beaucaire and Fourques (right bank of the Rhône)

- Safety works for the whole system to avoid any breaches during an exceptional Rhône flood.
- Implementation of long spillways on levees to resist overflow. They are made of concrete rip rap blocks on crest and landward side. This allows them to resist to high velocities in case of an overflow, which can create breaches on non-reinforced levee sections.

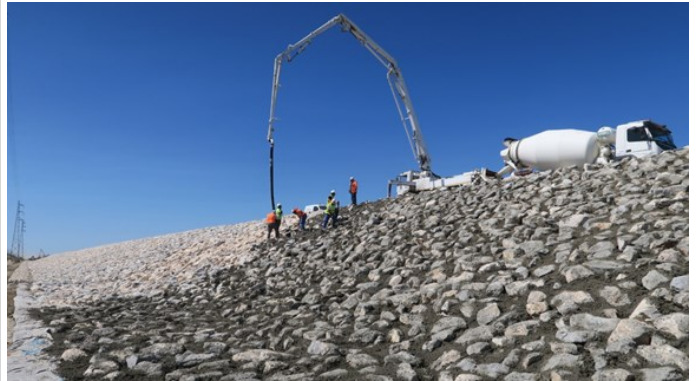
Figure 11: Levee resisting to overflow between Tarascon and Arles (left bank of the Rhône). Copyright SYMADREM.

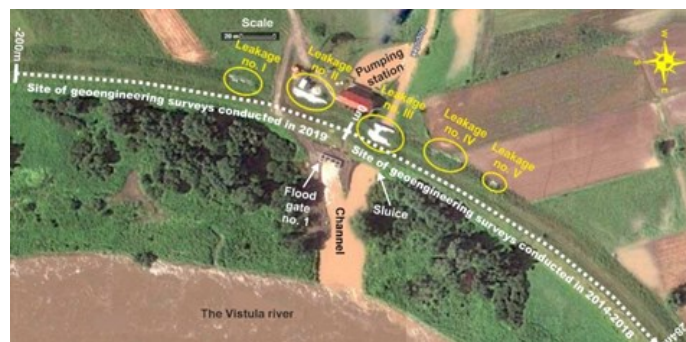
Figure 14: View of the investigated levee of the Vistula River with marking of the leakage zones observed during the great flood in 2010. (Radzicki et al., 2021)

On the examined section of the levee during the great flood of 2010, leakages and minor internal erosion processes in several separate zones were observed in the toe of the land side slope. These places were provisionally secured with a layer of sandbags (white zones in yellow ellipses presented in Figure 14) during the flood. There were hundreds of such places just after the flood in 2010 in only one region of the Małopolskie Voivodeship. This raised the question of what methods, and which optimized methodology of levee investigations should be used during and after a flood, to clearly identify those levee sections that require in the first place renovation or even emergency reinforcement, e.g., with a sheet piling, preferably before the next flood. The answer to this question was one of the main goals of the aforementioned grant and the levee investigations.

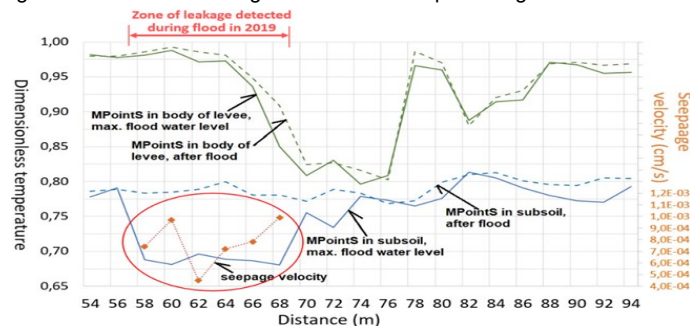
Figure 16: Results of measurements with active thermal sensors during and after the period of water level increase in the Vistula river in May 2019 and the corresponding values of the seepage velocity in the leak detected zone. (Radzicki et al., 2021)

In May 2019, the first higher rise of water in the Vistula took place in several years. However, the flood level was not very high and submerged the water side slope only on several dozen centimetres high. The leakage thermal monitoring system performed measurements. The MPointS sensors detected the leak in zone 4 (Figure 16) and measured its seepage velocity in the soil. This zone is the deepest located of the zones where leaks were observed during the great flood in 2010 (Figure 14). The seepage velocities were much lower than the critical ones necessary for the erosion process to occur. Other leakage zones observed during the 2010 flood require a higher flood level to fill them with water.

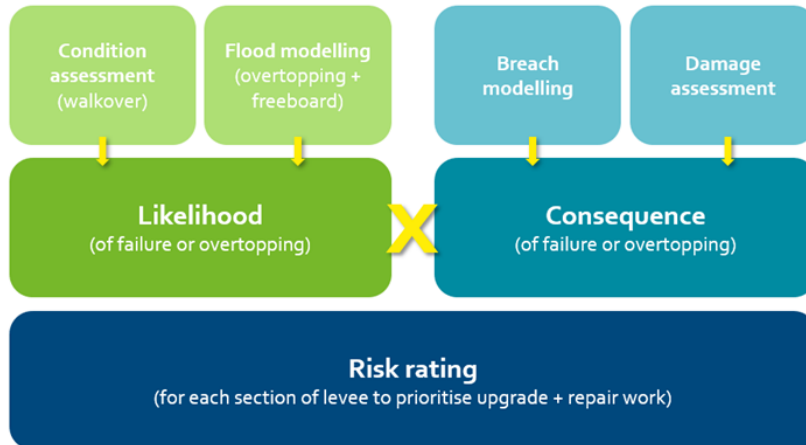
Figure 1: Risk assessment approach

The approach used for the study is summarised in Figure 1, and the study location shown in Figure 2.

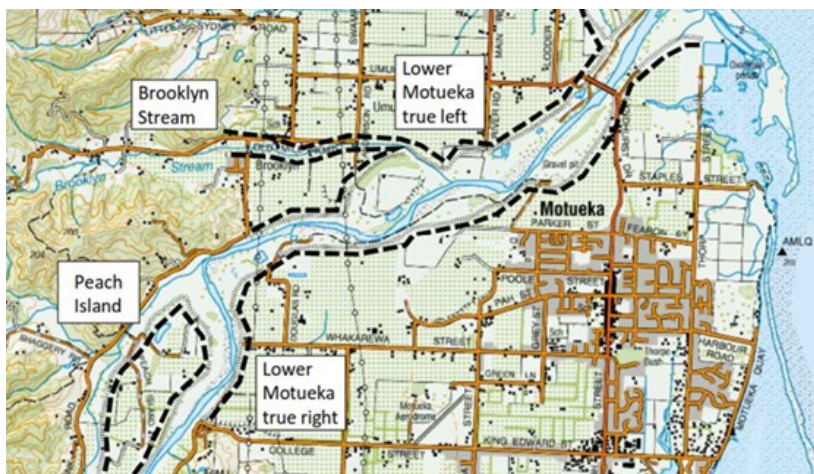
Figure 2: Study location. Dashed black lines show levee alignment

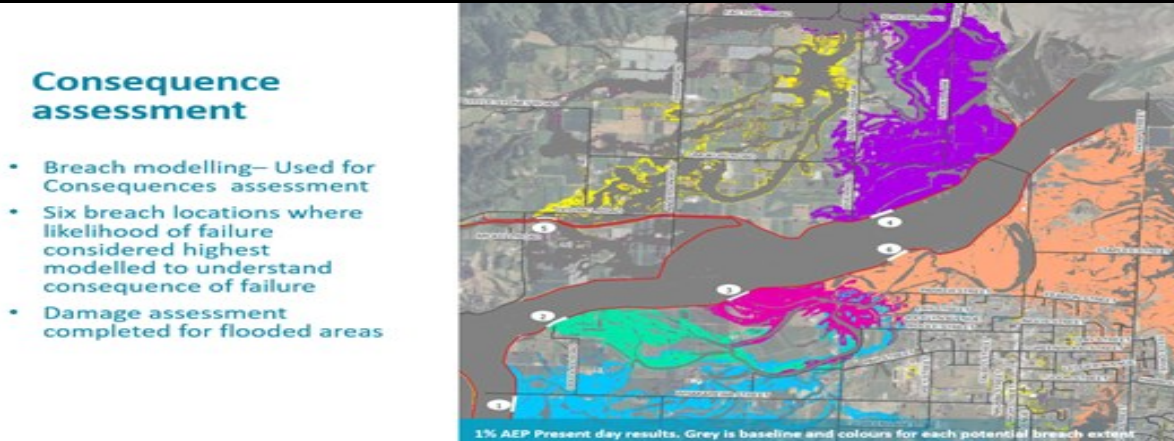
Figure 4: Breach modelling results for each breach location

The TUFLOW 2D hydraulic model was used firstly to simulate flooding that may occur due to capacity constraints in the local stormwater drainage system in the design flood event (baseline), then to assess the incremental additional flooding that would occur from a levee breach. Six locations for levee breaches were selected on the basis of having the highest likelihood of failure. The results of the breach analyses are summarised in Figure 4 with the flood extent from each breach location being represented in a different colour. The following criteria were considered to assess the incremental consequence associated with each breach location.

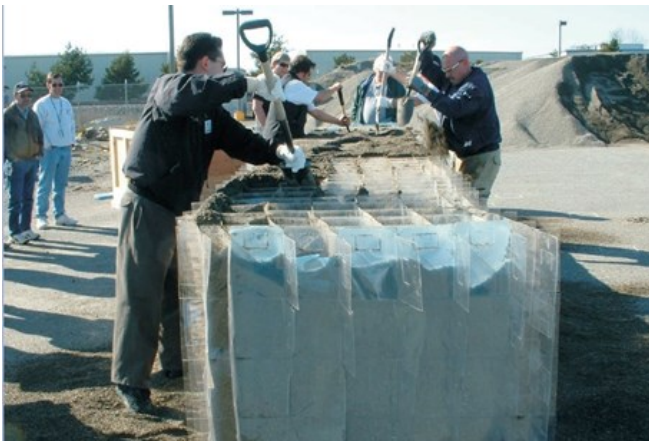
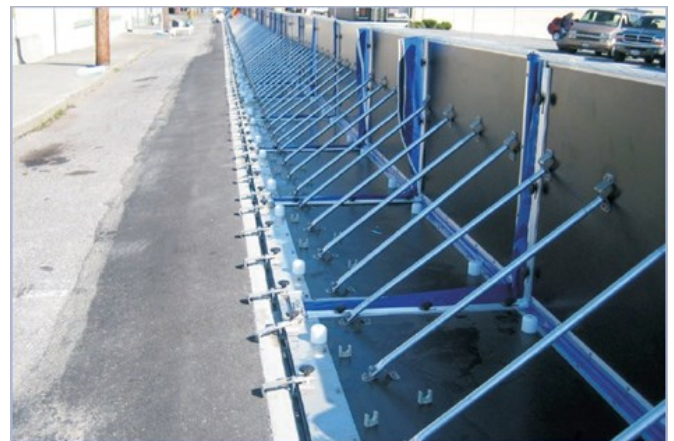
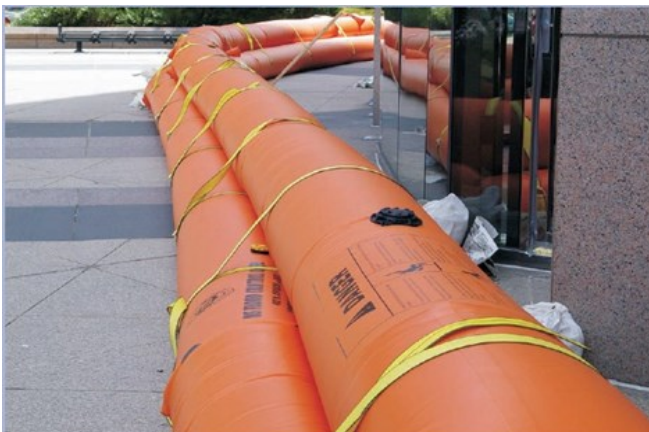
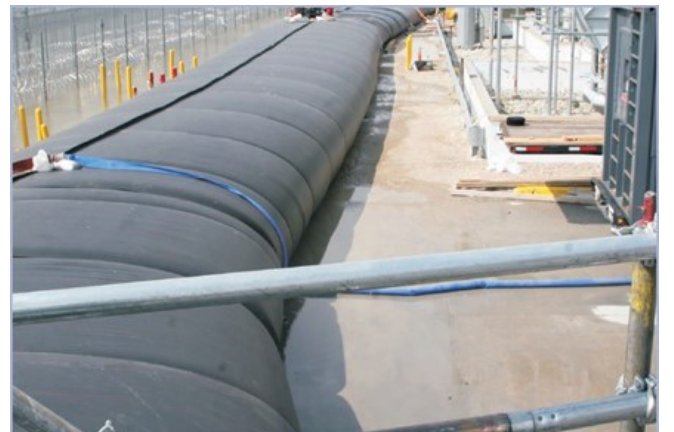
Figure 1: Illustrations taken from the International Levee Handbook (courtesy USACE)

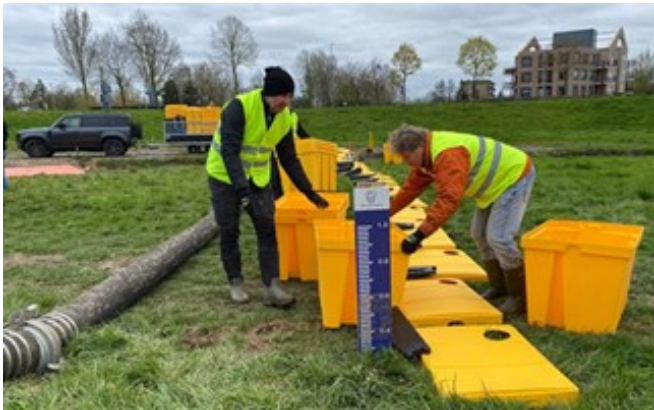
Figure 1: Boxbarrier BV

The test setup took place near the Roer River in Roermond on April 6, 2022. Both in the morning and in the afternoon two setups were tested. Using pumps from WL, a high-water situation was simulated and approximately 40 meters of all systems were set up. WL had constructed two temporary culverts in advance for this purpose to enable the test to be carried out. The test set-up was attended by various advisors from WL from crisis management to employees responsible for equipment maintenance. Also present were representatives of the Safety Region, the Fire Department and Delft University of Technology. There was also administrative interest from various representatives as well as from WL's communications department. In addition, interested media were also present on this day.

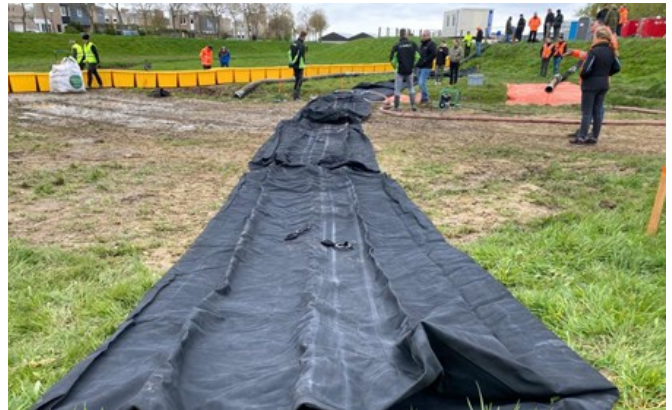
Figure 2: Slamdam BV

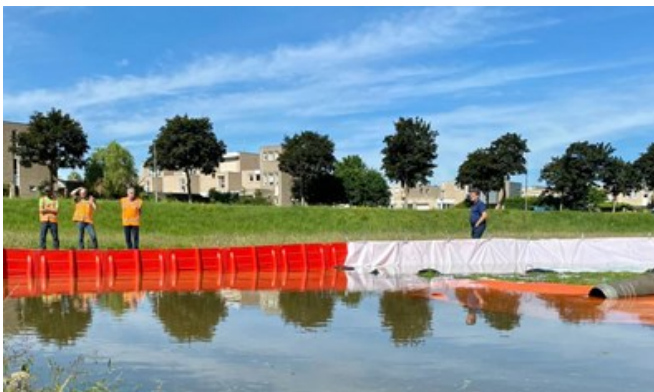
Figure 3: Waterschot BV

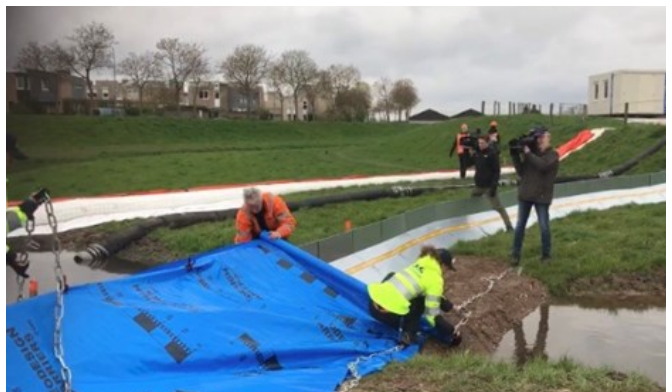
Figure 4: Geodesign AB

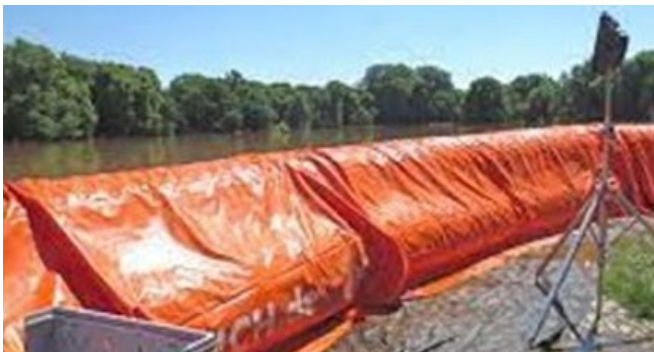
Figure 5: Mobile Dyke

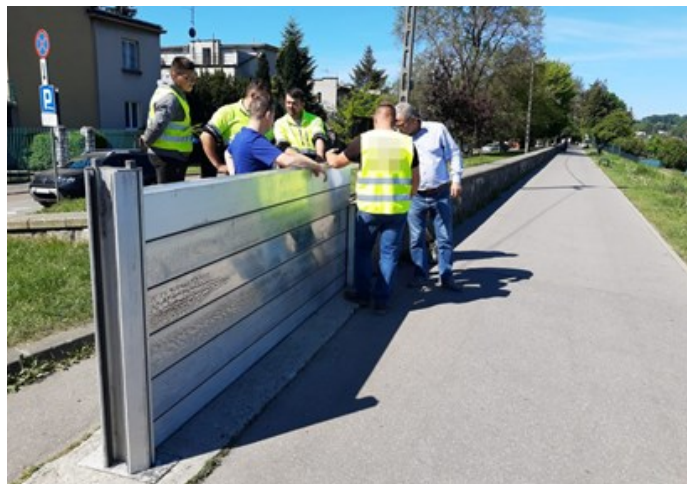
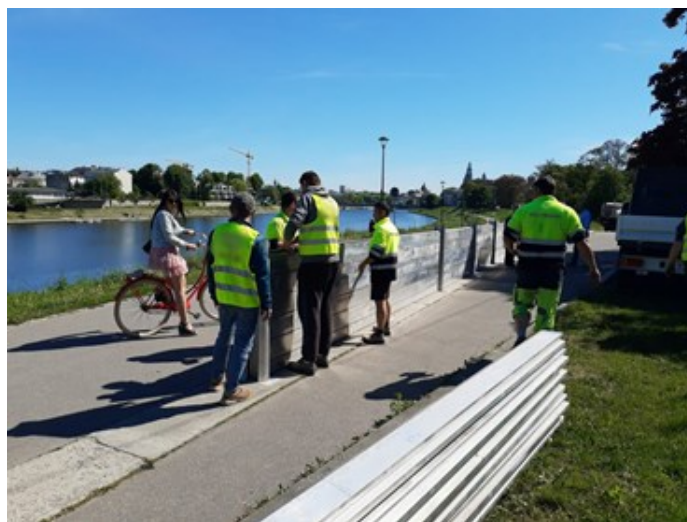
## Installation of a system in Krakow, Poland
