LEVEES WORKING GROUP NEWSLETTER

Issue 12 | November 2025

THE WORKING GROUP ON LEVEES AND FLOOD DEFENCES UNDER THE EUROPEAN CLUB OF ICOLD

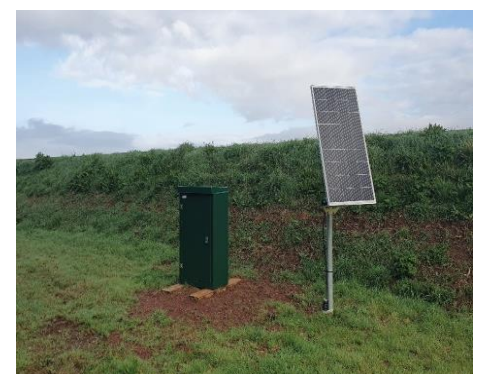
Figure 3: A completed PRIME system installation at Powderham Banks. All cables are buried for protection and to minimise visual intrusion. The system is fully autonomous and operates on solar power.

AtkinsRéalis used a Proactive Infrastructure Monitoring and Evaluation (PRIME) resistivity monitoring system from the British Geological Survey to better understand when failures might occur (Chambers et al., 2022). This was installed across the most vulnerable 1.3km of the embankment to identify and monitor seepage through the structure (Figure 2 and Figure 3).

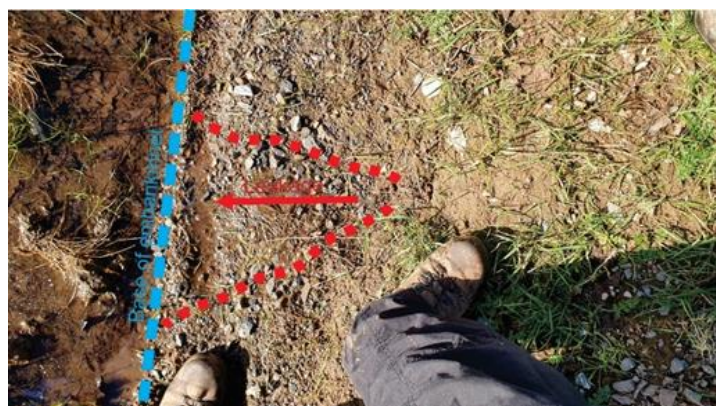
Figure 5: Low-level leakage identified at the location of 'January resistivity south' from the PRIME data.

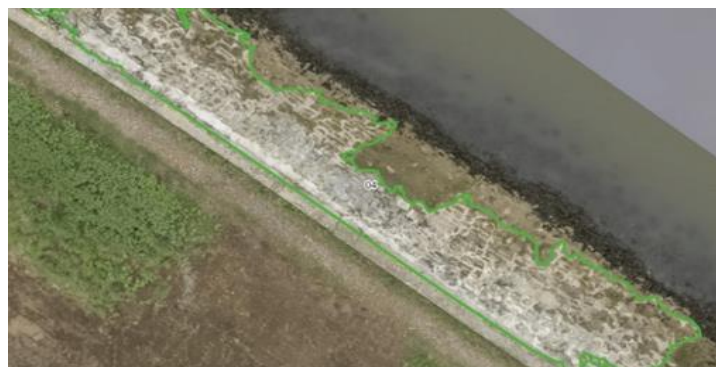
Figure 6: An example of a marine mortar repair (estuary face) and excavation and re-compaction repair to a piping failure (landward face). The marine mortar repair costs ~£100k less for the extents shown

The early identification of the low-level leakage allows for early intervention using less expensive and less environmentally impactful repairs. At the location identified in January 2025, a marine mortar was used to repair the revetment blockwork on the estuary face. This work aims to reduce the water infiltrating through the embankment, preventing the progression of leakage to piping failure. An aerial image from a drone survey in December 2024 (Figure 6) shows a marine mortar repair to the estuary face and a corresponding intrusive repair to the landward face following a piping failure in October 2024. In this example, the extents of the marine mortar repair costs ~£25k, compared to the intrusive repair which costs over £100k. PRIME monitoring means these early indicators of leakage can be identified and fixed before they become more significant failures. Furthermore, the PRIME data can monitor the efficacy of these repairs, to ensure that the inferred moisture content of the embankment interior is decreasing following estuary face repairs.

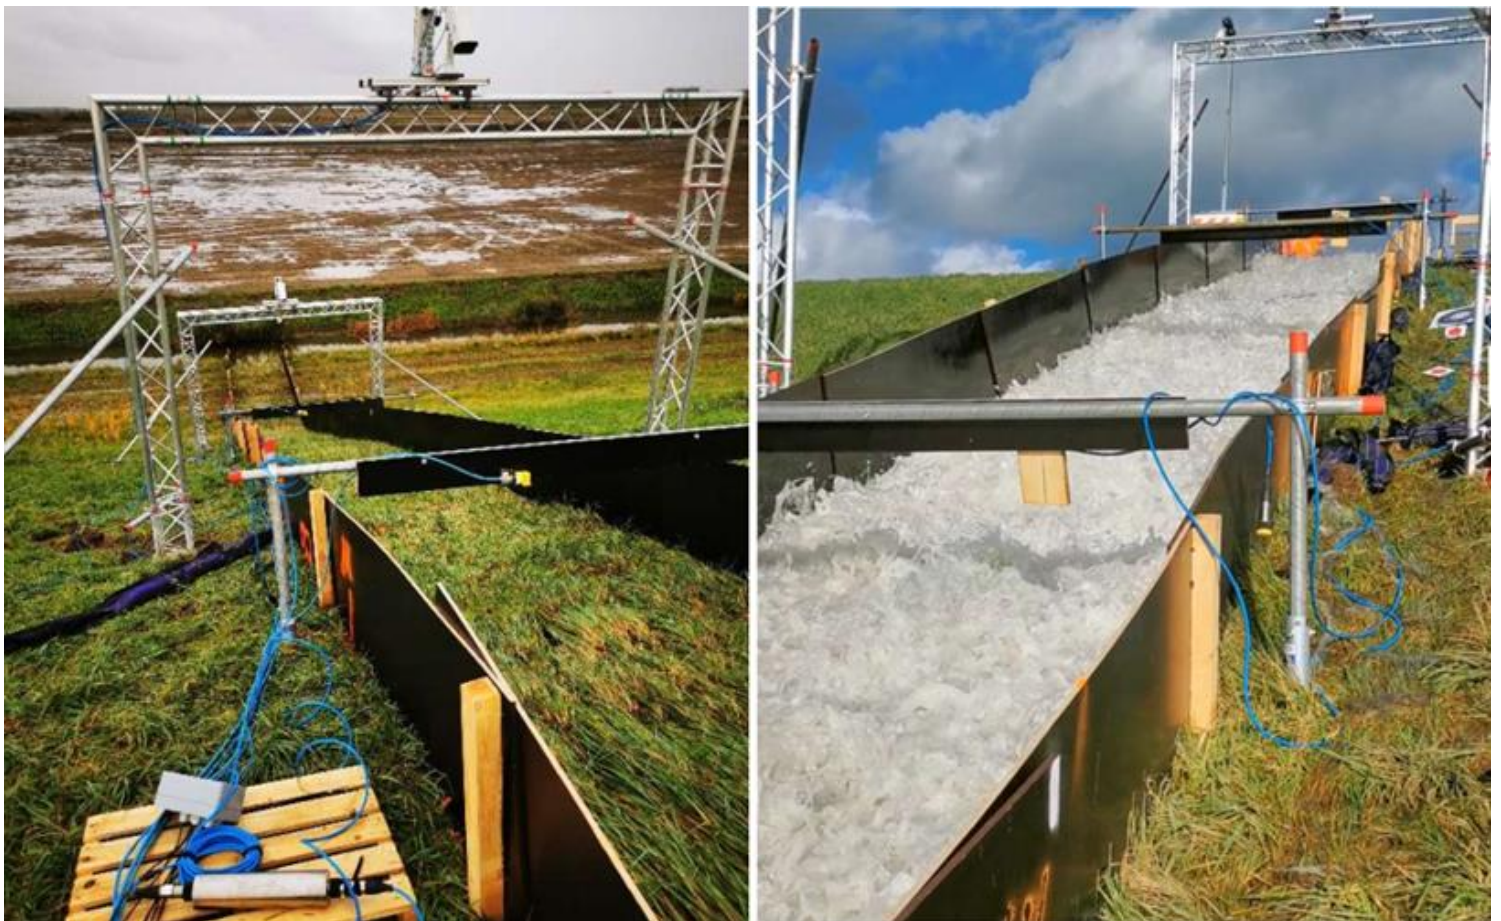
Figure 1: View of the setup and monitoring system on the levee slope before and during overflow. The installation features overhead cameras, and water level and velocity meters.

Within the INTERREG-project Polder2C's, 27 full-scale overflow tests were executed on levee sections with varying vegetation states and structural anomalies. To establish a continuous overflow with controlled characteristics on the landward side of the levee, an overflow generator was developed and built by Flanders Hydraulics (Figure 1).

The design and application of the overflow generator is described by Vercruysse et. al [2]. The overflow generator was placed on the upper part of the riverside levee slope. The flow crosses first the levee crest and then flows down the levee slope at the landward side. The flow is contained between plywood boarding walls inserted into slits in the levee cover layer to limit leakage. The width of a stream section was typically 2m, though it was reduced for some tests to increase the specific discharge. The overflow tests were executed in different sessions of 1-2 hours, with only brief interruptions (5-10 min) to evaluate the state of the grass cover and detect developing defects or irregularities. During these interruptions, images were captured with a camera system. Instrumentation included acoustic water level sensors, electromagnetic velocity meters, and a camera system. Data was collected continuously and processed using statistical and geospatial techniques.

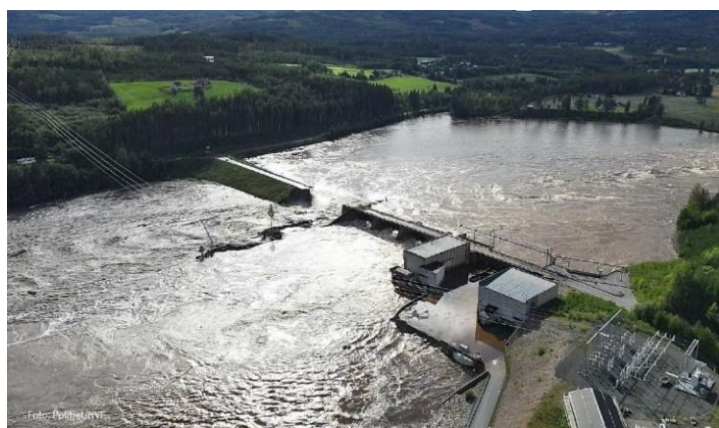
Figure 3: Dam Braskereidfoss during the embankment dam failure (Photo: Police/NVE)

The dam constructed in 1978 provided water to a run-off-the-river power plant. It consisted of a 22,5m high embankment and a concrete dam section (slab buttress), including the spillway gates, and was classified in dam class 1 (low consequence, second lowest of a 5 class-scale, 0-4). Fortunately, there were no fatalities, and the dam breach wave did not increase considerably due to already high flood water levels downstream. The gates were opened 20% around midnight, and in the morning of the 9th of August overtopping of the slab buttress started in the morning. Overtopping of the embankment started at 11:15 and the dam failed at 16:30, see figure 3. The flood discharge was 2100 m³/s at this time, corresponding to a flood with a return period of ca.50 years. The design flood for the dam had a return period of 500 years, corresponding to 3573 m³/s. The incident investigation report (DNV, 2023) concludes that the reason was not error or fail of the technical system. The situation was not identified to be severe due to several underlying reasons, mainly a combination of technical vulnerability and human and organizational circumstances.

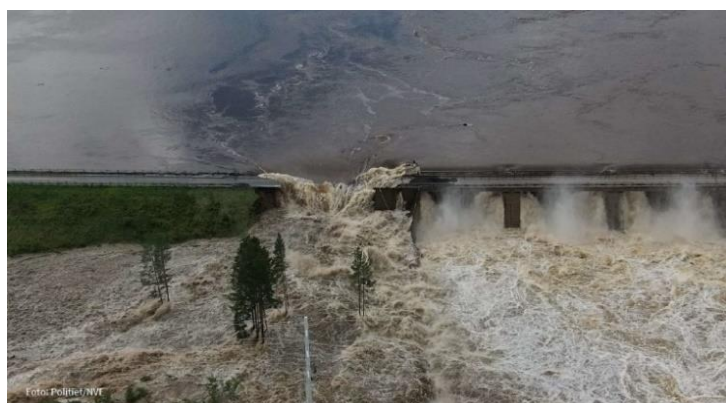
Figure 4: Overtopping of the embankment at dam Braskereidfoss (Photo: Politiet/NVE)

The following information is based on a presentation by NVE 11.12.2023 with information from the dam owner (NVE, 2023 b), and the incident investigation report (DNV, 2023). Partly closed spillway gates at Braskereidfoss dam in the river Glomma caused uncontrolled rising water levels, overtopping and finally dam breach on 9th August 4.
